September 25, 2020

Willbrook Plantation Association  
426 Tidewater Circle  
Pawleys Island, South Carolina 29585

Reference: **Report of Pavement Exploration Results with Recommendations  
Willbrook Plantation**  
Murrells Inlet, South Carolina  
S&ME Project No. 1363-20-023

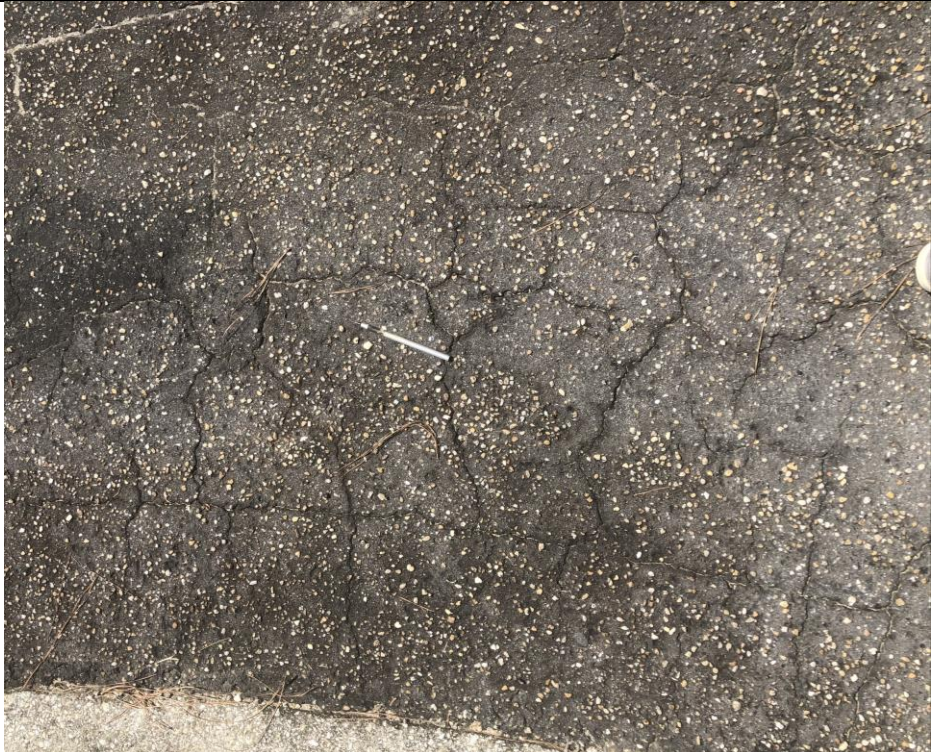
**Photo 1: Aggregate Polishing**

Polished aggregates were observed on nearly all of the pavement surfaces observed to some degree. Polishing occurs when the bitumen (the asphaltic material) on top of the aggregates in the asphalt mixture has worn away. Over time, most aggregates are susceptible to wearing to a smooth finish or texture under repeated traffic. This may reduce traction and contribute to loss of ductility. It also reduces the adhesion of surface sealers that may be applied. See **Photo 1** below for an example of the distress observed.

Date: 9/23/2020
		Photographer: K. Fugate
<b>Location / Orientation</b>	Lupton Lane	
<b>Remarks</b>	Moderate aggregate polishing with fatigue cracking.

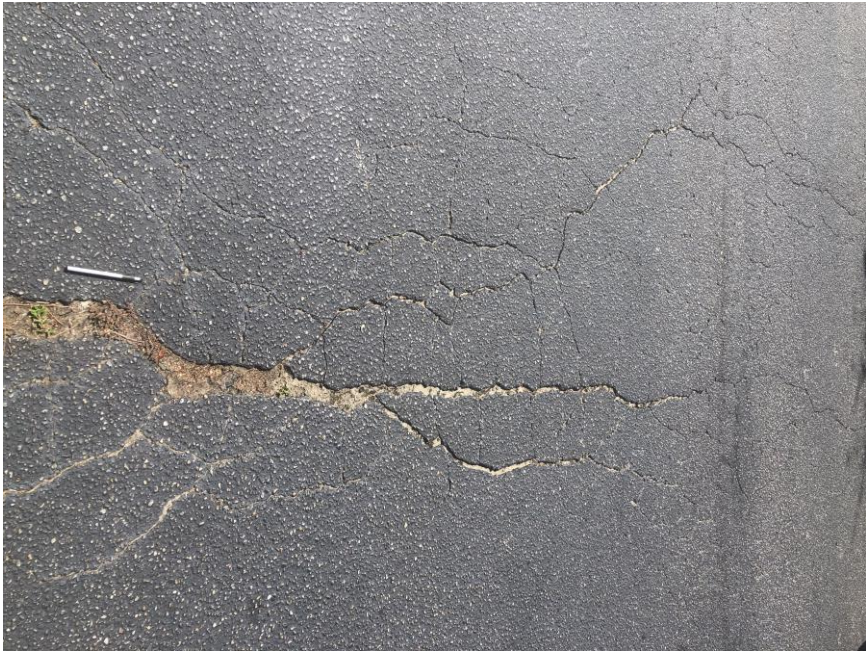
**Photo 2: Transverse Cracking**

Slight to moderate transverse cracking was observed on most of the roadways observed. Transverse cracks are those oriented generally perpendicular to the pavement centerline. This type of cracking may be caused by fatigue or shrinkage of the asphalt, or deformation of the base or subgrade, or in some cases may be associated with root heaves. See **Photo 2** below for an example of transverse cracking.

Date: 9/23/2020
		Photographer: K. Fugate
<b>Location / Orientation</b>	Black Duck Road	
<b>Remarks</b>	Note moderate transverse cracking.

- S&ME has not solicited a proposal for this work from any contractors.
- We typically recommend sealing longitudinal and transverse cracks that are ¼ inch wide or greater. *Exception:* sealing cracks in severely fatigue-cracked pavement (such as where alligator cracking has occurred) is not typically effective and is not recommended.
- While drainage improvements are being made as a result of the pipe inspection, it may also be appropriate to perform some isolated full-depth patching to fix any sinkholes and other small areas requiring immediate attention.

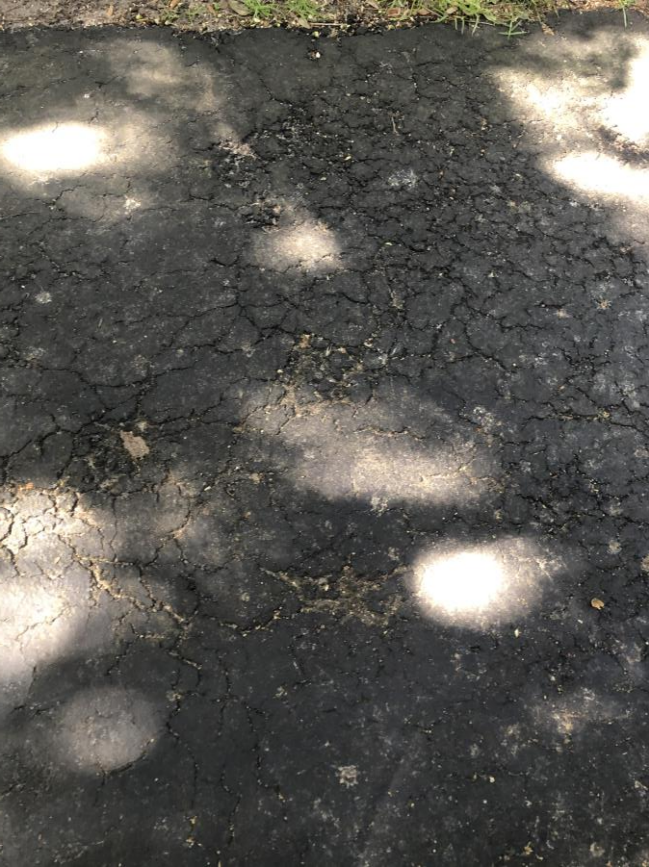
**Photo 3: “Alligator” Fatigue Cracking**

Fatigue (“alligator”) cracking was observed on several of the roadways, usually (but not always) in areas where depressions have developed in the surface of the pavement. Alligator cracking generally indicates areas where the base course and/or subgrade are weaker than necessary to support the applied traffic loads, and/or the asphalt is too thin for the wheel loads applied. The deflection of the pavement under traffic loading in these areas eventually causes the asphalt to break up and separate into small pieces (which resemble the skin texture of an alligator, thus the name). This pattern is due to excess tensile stress and strain at the bottom of the asphalt layer. Some of the roadways that we explored displayed moderate alligator cracking, indicating a prolonged period of distress. See **Photo 3** below for an example of the distress observed.

Date: 9/23/2020
		Photographer: K. Fugate
<b>Location / Orientation</b>	Heston Point Drive	
<b>Remarks</b>	Moderate alligator cracking.

In areas which are exhibiting moderate to severe fatigue cracking, alligator cracking, or severe root heave damage, it will be necessary to remove and replace the asphalt pavement in these localized areas. We do not anticipate these areas to be widespread, but there will be several of these areas that should be prepared by full-depth patching prior to constructing any new pavement overlay. S&ME can identify, quantify, measure, and mark each of these specific areas during development of project specifications for construction.

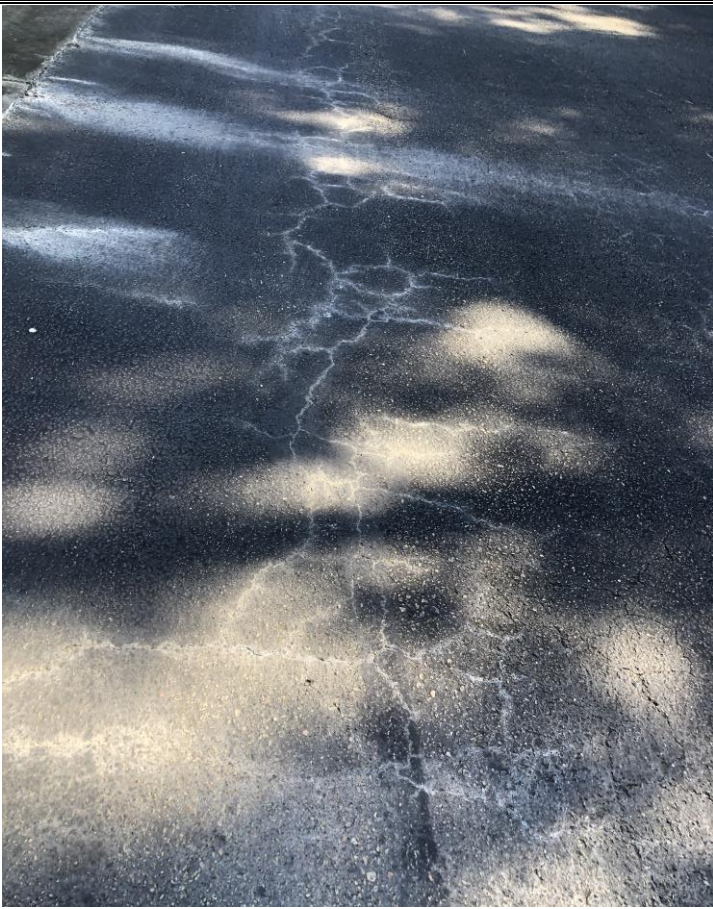
**Photo 5: Percolation**

Evidence of percolation damage was observed on Heston Point Drive, Sandy Meadow Loop, and Ruddy Duck Lane. Percolation results from the presence of water beneath the asphalt, combined with a poorly draining base course, and/or lack of adequate subsurface drainage. Water becomes trapped beneath the pavement and is

unable to escape to the sides or infiltrate downward; sometimes, often during the hottest periods of the year, the water will escape by percolating up through the cracks in the surface. This symptom is often associated with base materials that have a low drainage capacity. Evidence of percolation includes the deposition of fines on the pavement surface, often seen as a tan or gray stain; these deposits are actually small particles of the base material that have been transported to the surface by the percolating water. See **Photo 5** below for an example of the distress observed.

Date: 9/23/2020
		Photographer: K. Fugate
<b>Location / Orientation</b>	Ruddy Duck Lane	
<b>Remarks</b>	Moderate percolation with surface staining in combination with some fatigue cracking.

Based upon our observations, we recommend that pavement underdrains be installed along the side of the road near 280 Oatland Lake Drive. Underdrains should also be installed along Coleman Court from the intersection with Hamby Drive to the nearest catch basin, and along the side of the road near 629 Chapman Loop. There may be additional areas of underdrain to recommend after the civil engineering work is complete (see short term plan).

More specifically, we recommend that a fabric-wrapped, high-density polyethylene (HDPE), vertically-oriented slot drain such as ADS AdvanEDGE, or similar, be installed along the entire length of the affected sections. The underdrain can be placed behind the curb or in front of the curb; however, it is likely preferable in this case to install the underdrain immediately in front of the curb to reduce disruptions to existing driveways and utilities. Alternatively, the underdrains may be placed behind the curbs, although this approach would likely require cutting and patching of the residential concrete driveways, or borings under each driveway. A typical installation detail drawn by ADS is attached to this report in the appendix as **Figure 10** for reference regarding these options.

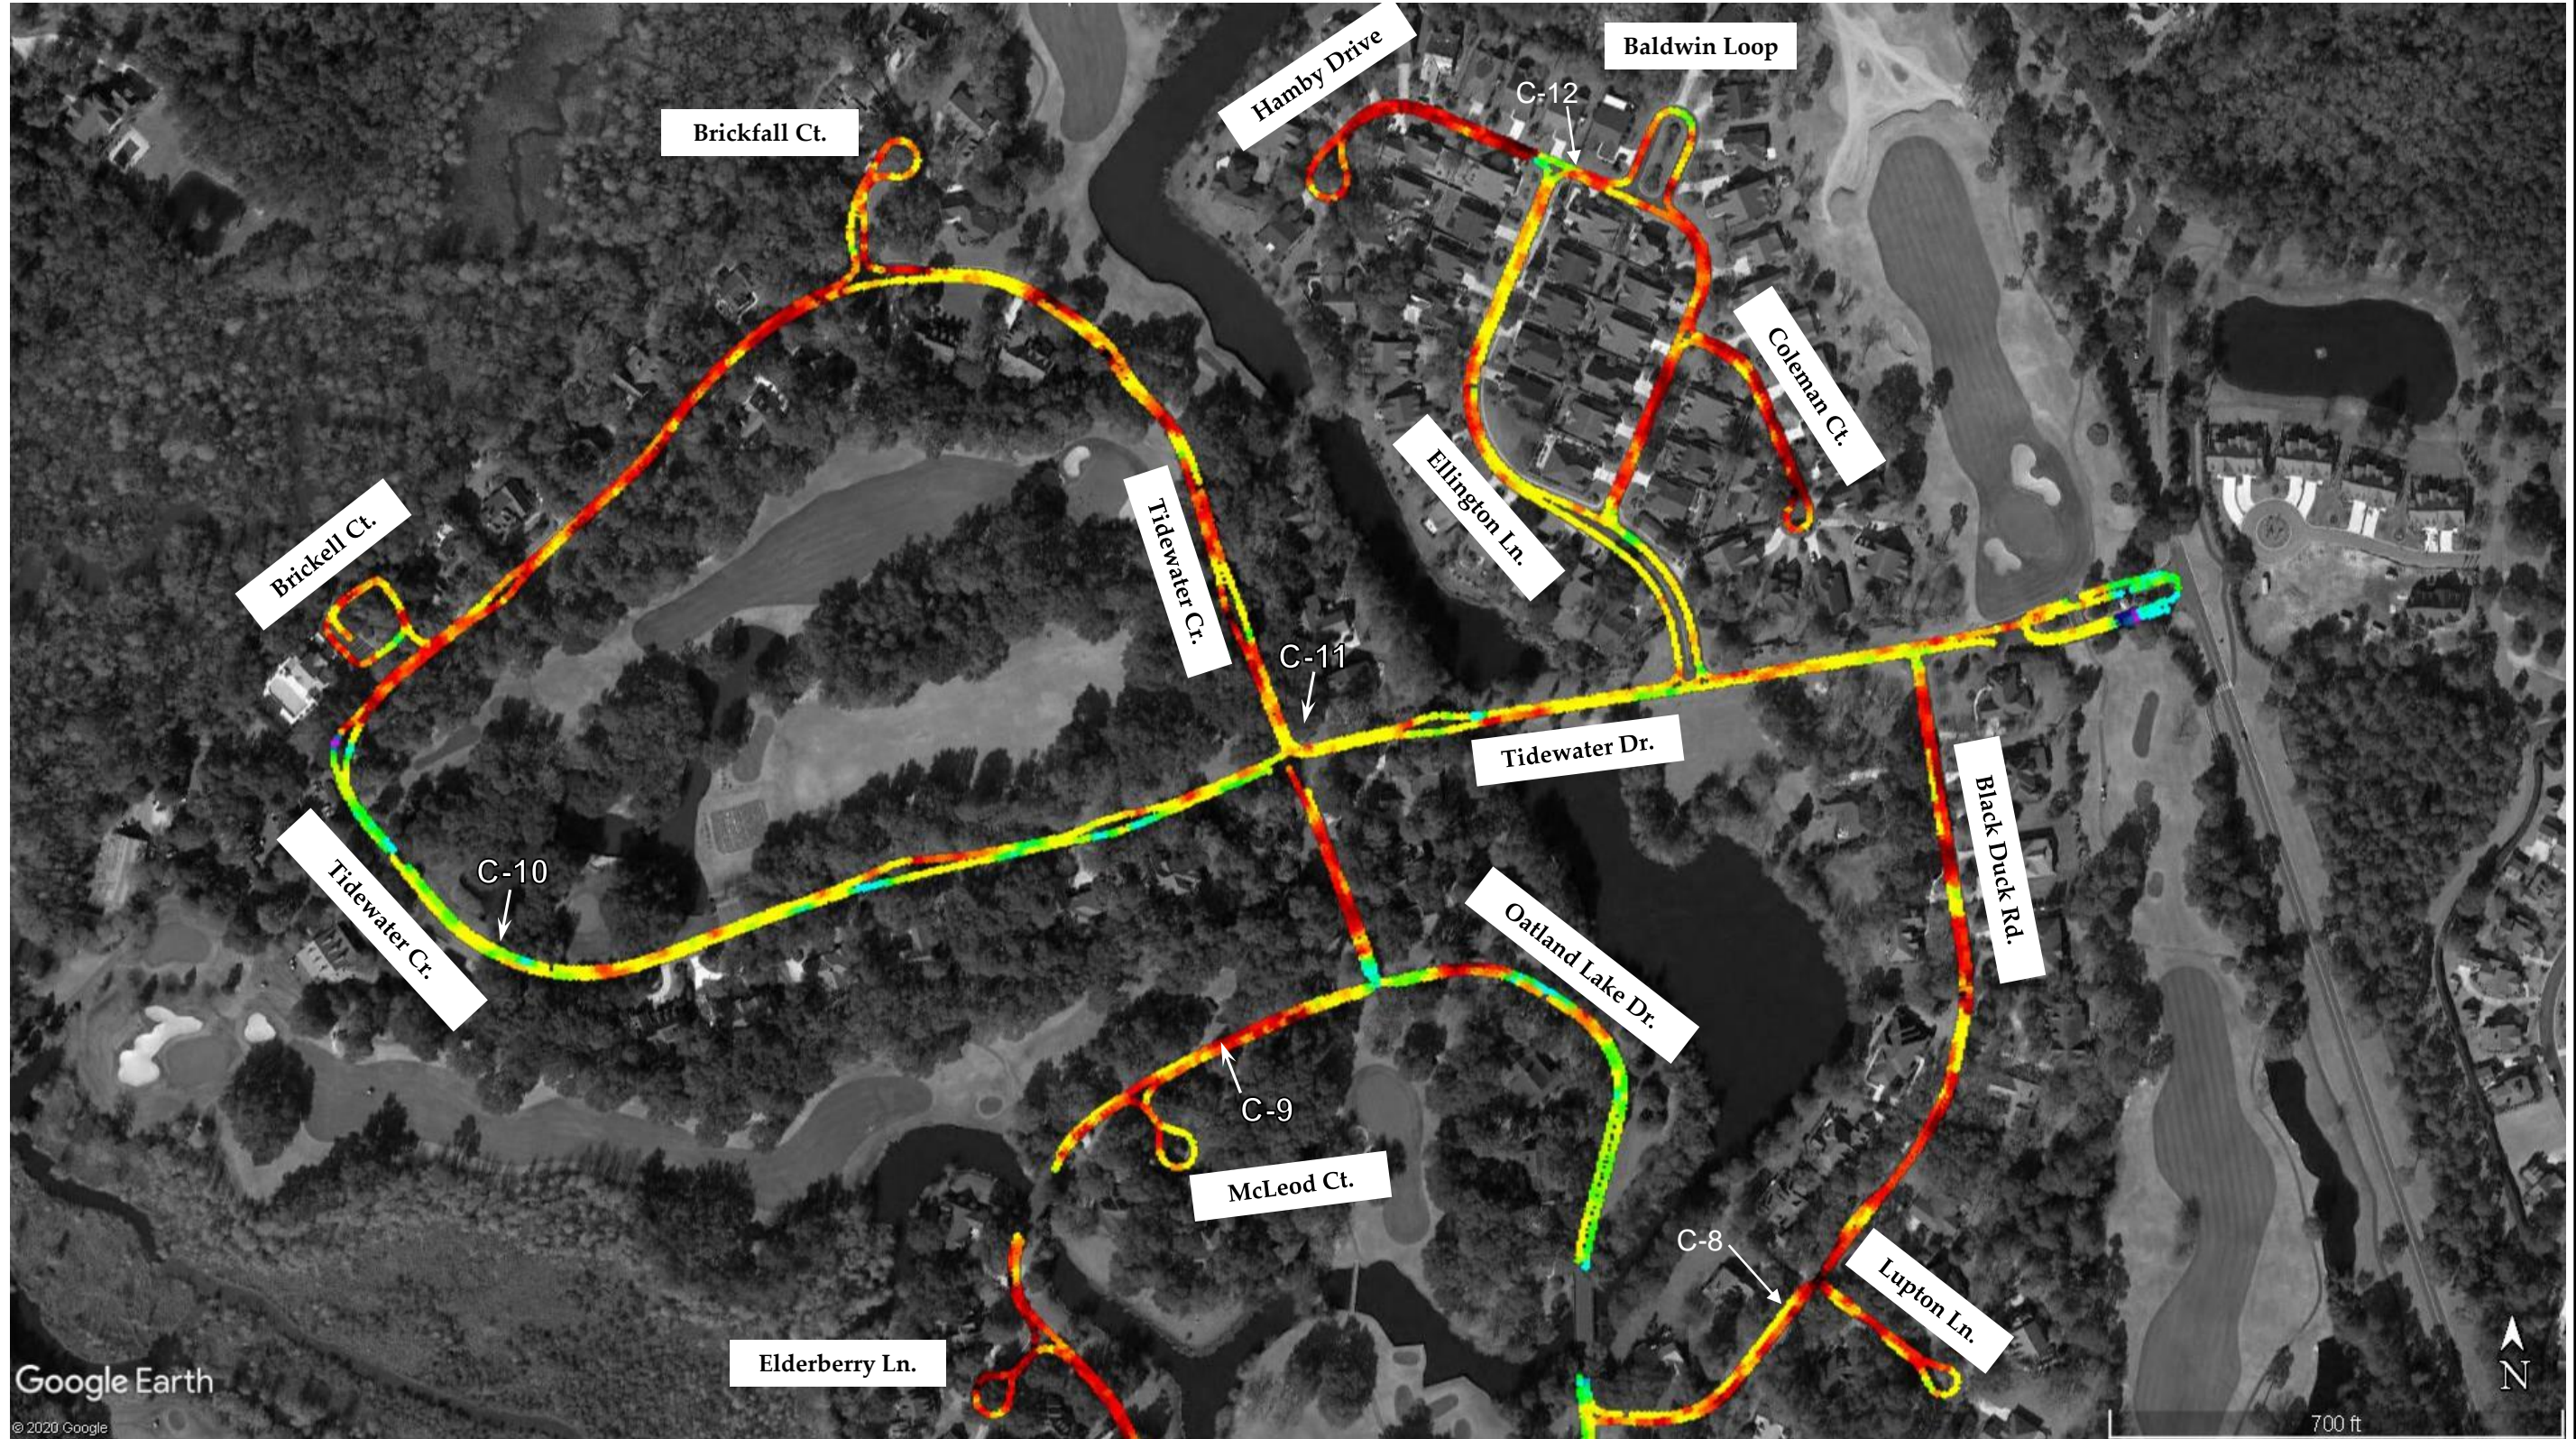
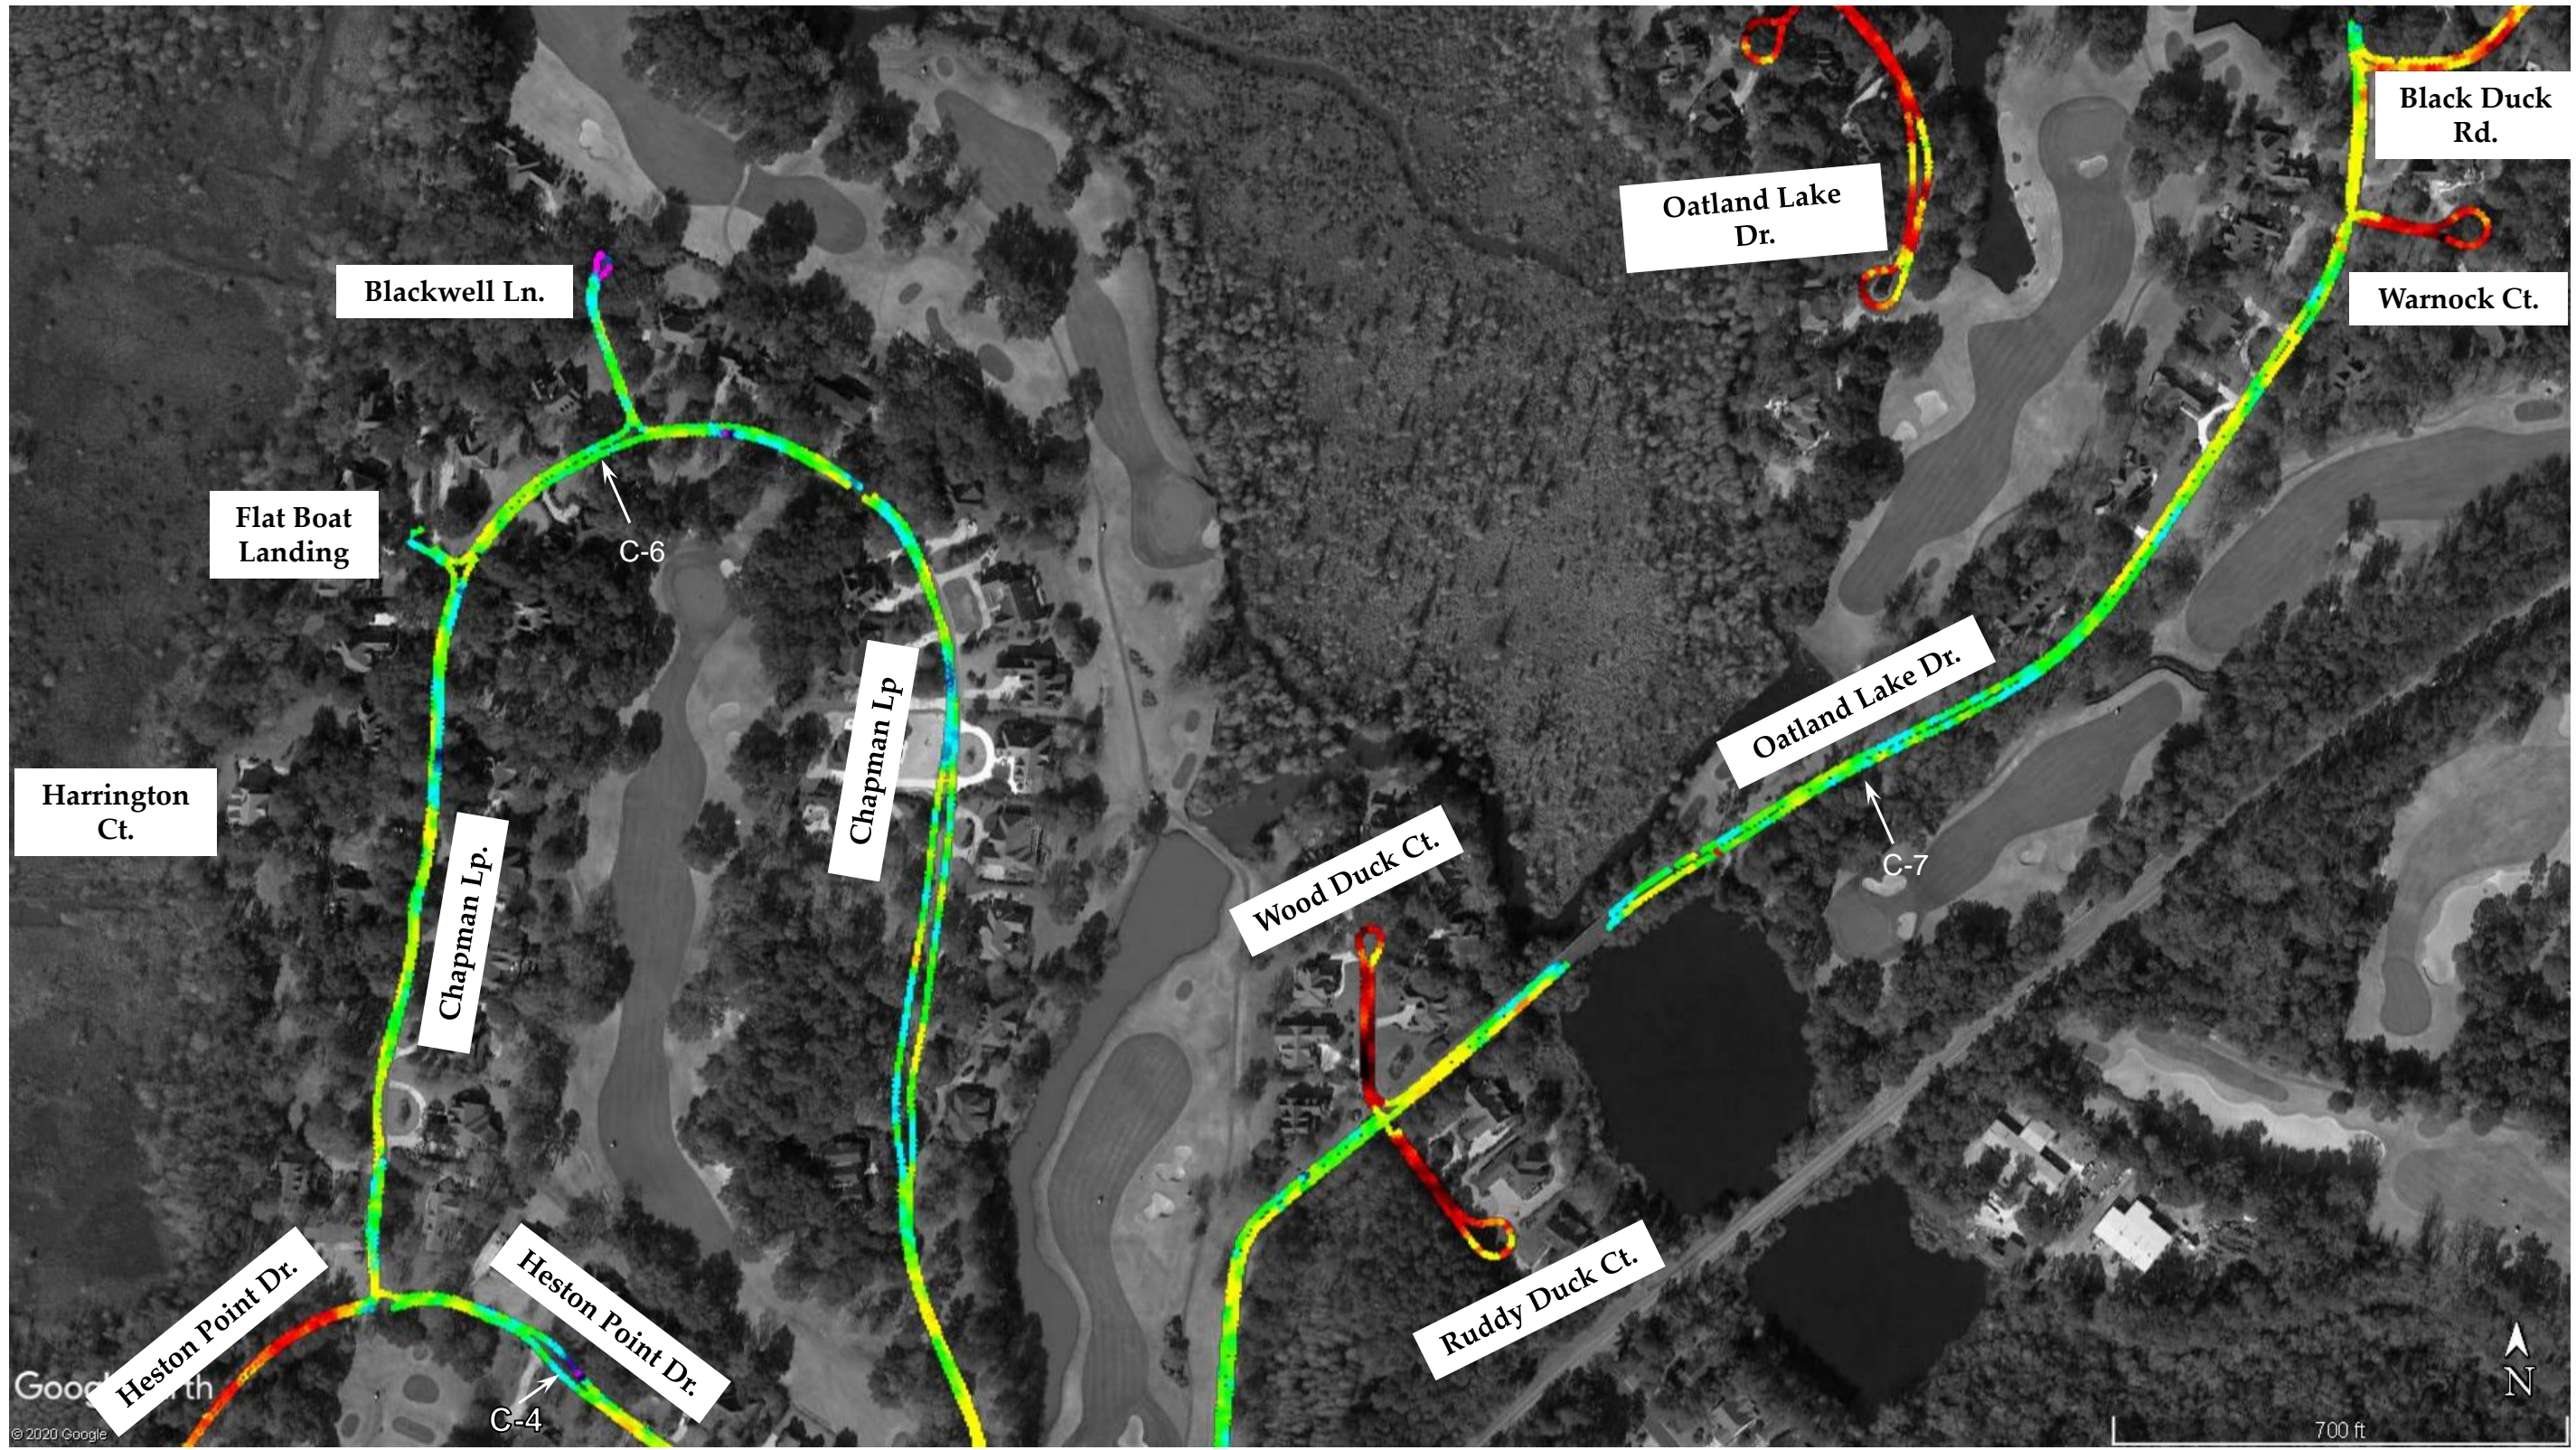
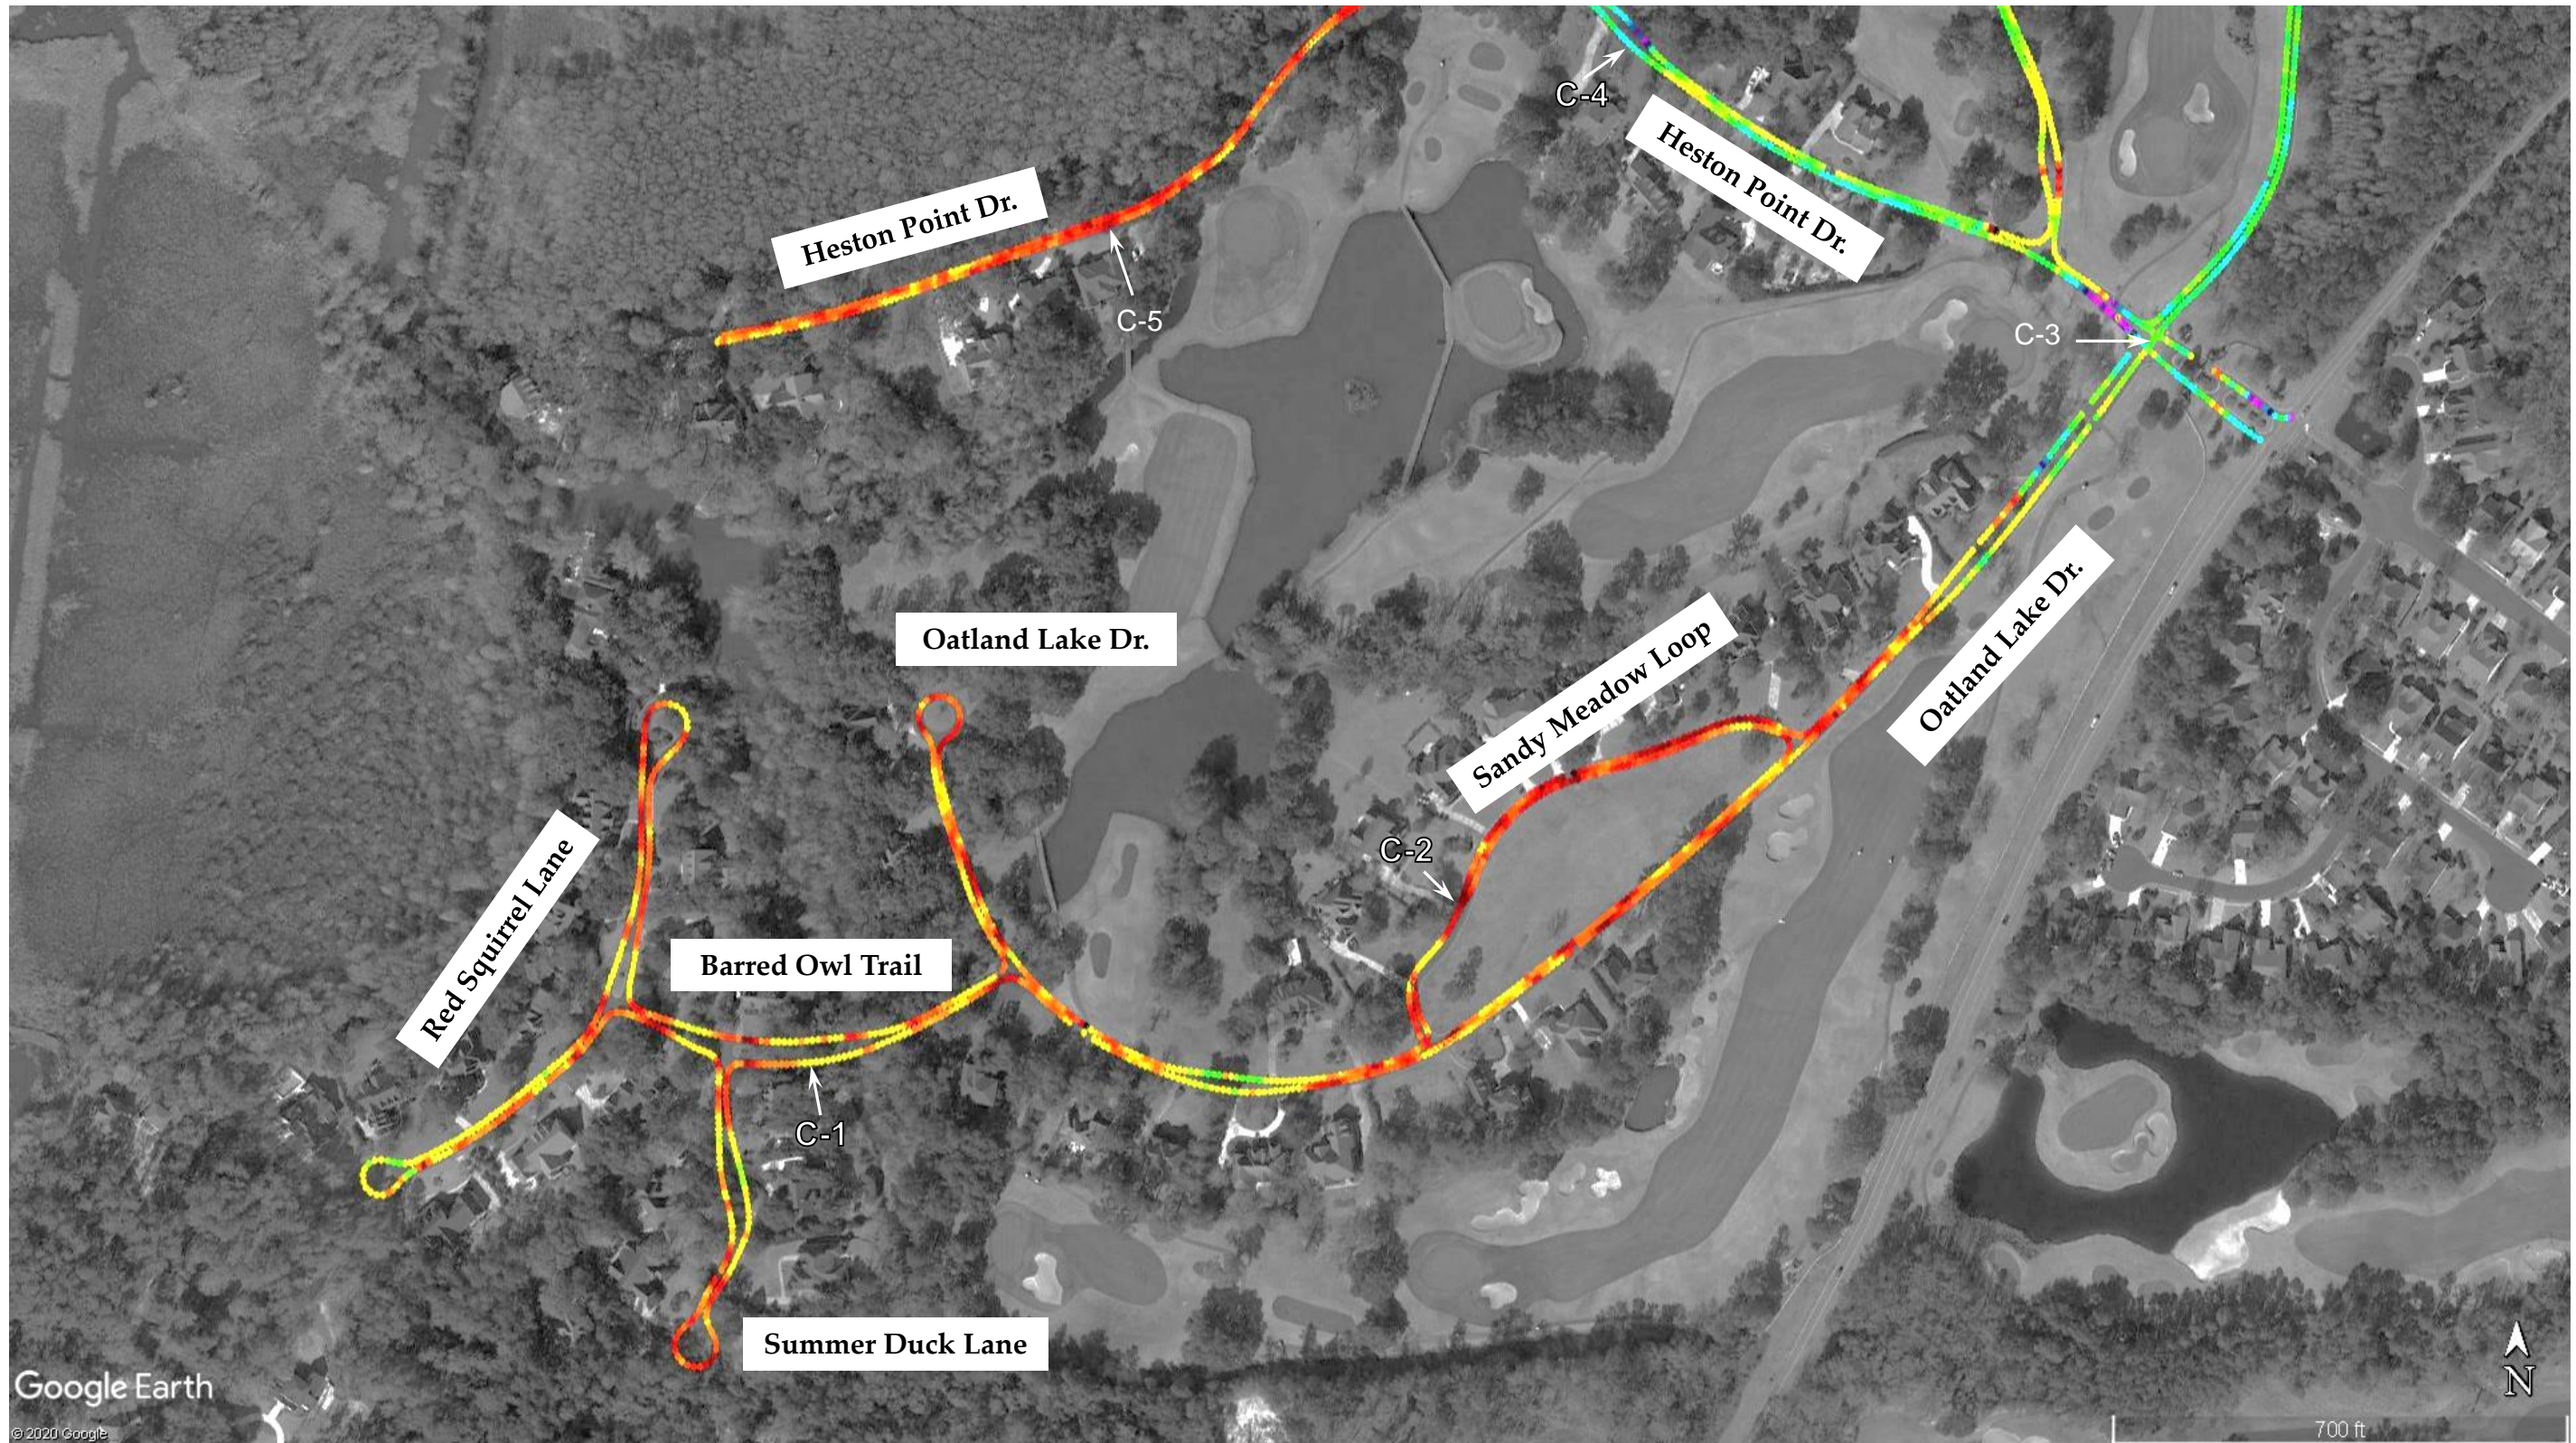
- A. Areas colored in **orange** and **red** on **Figures 2, 4, and 6** indicate areas where the asphalt appears to be less than 2 inches thick.
  - B. Areas colored in **orange** and **red** on **Figures 3, 5, and 7** indicate areas where the base course layer appears to be less than 6 inches thick.
