September 25, 2020

Willbrook Plantation Association  
426 Tidewater Circle  
Pawleys Island, South Carolina 29585

Reference: **Report of Pavement Exploration Results with Recommendations  
Willbrook Plantation**  
Murrells Inlet, South Carolina  
S&ME Project No. 1363-20-023

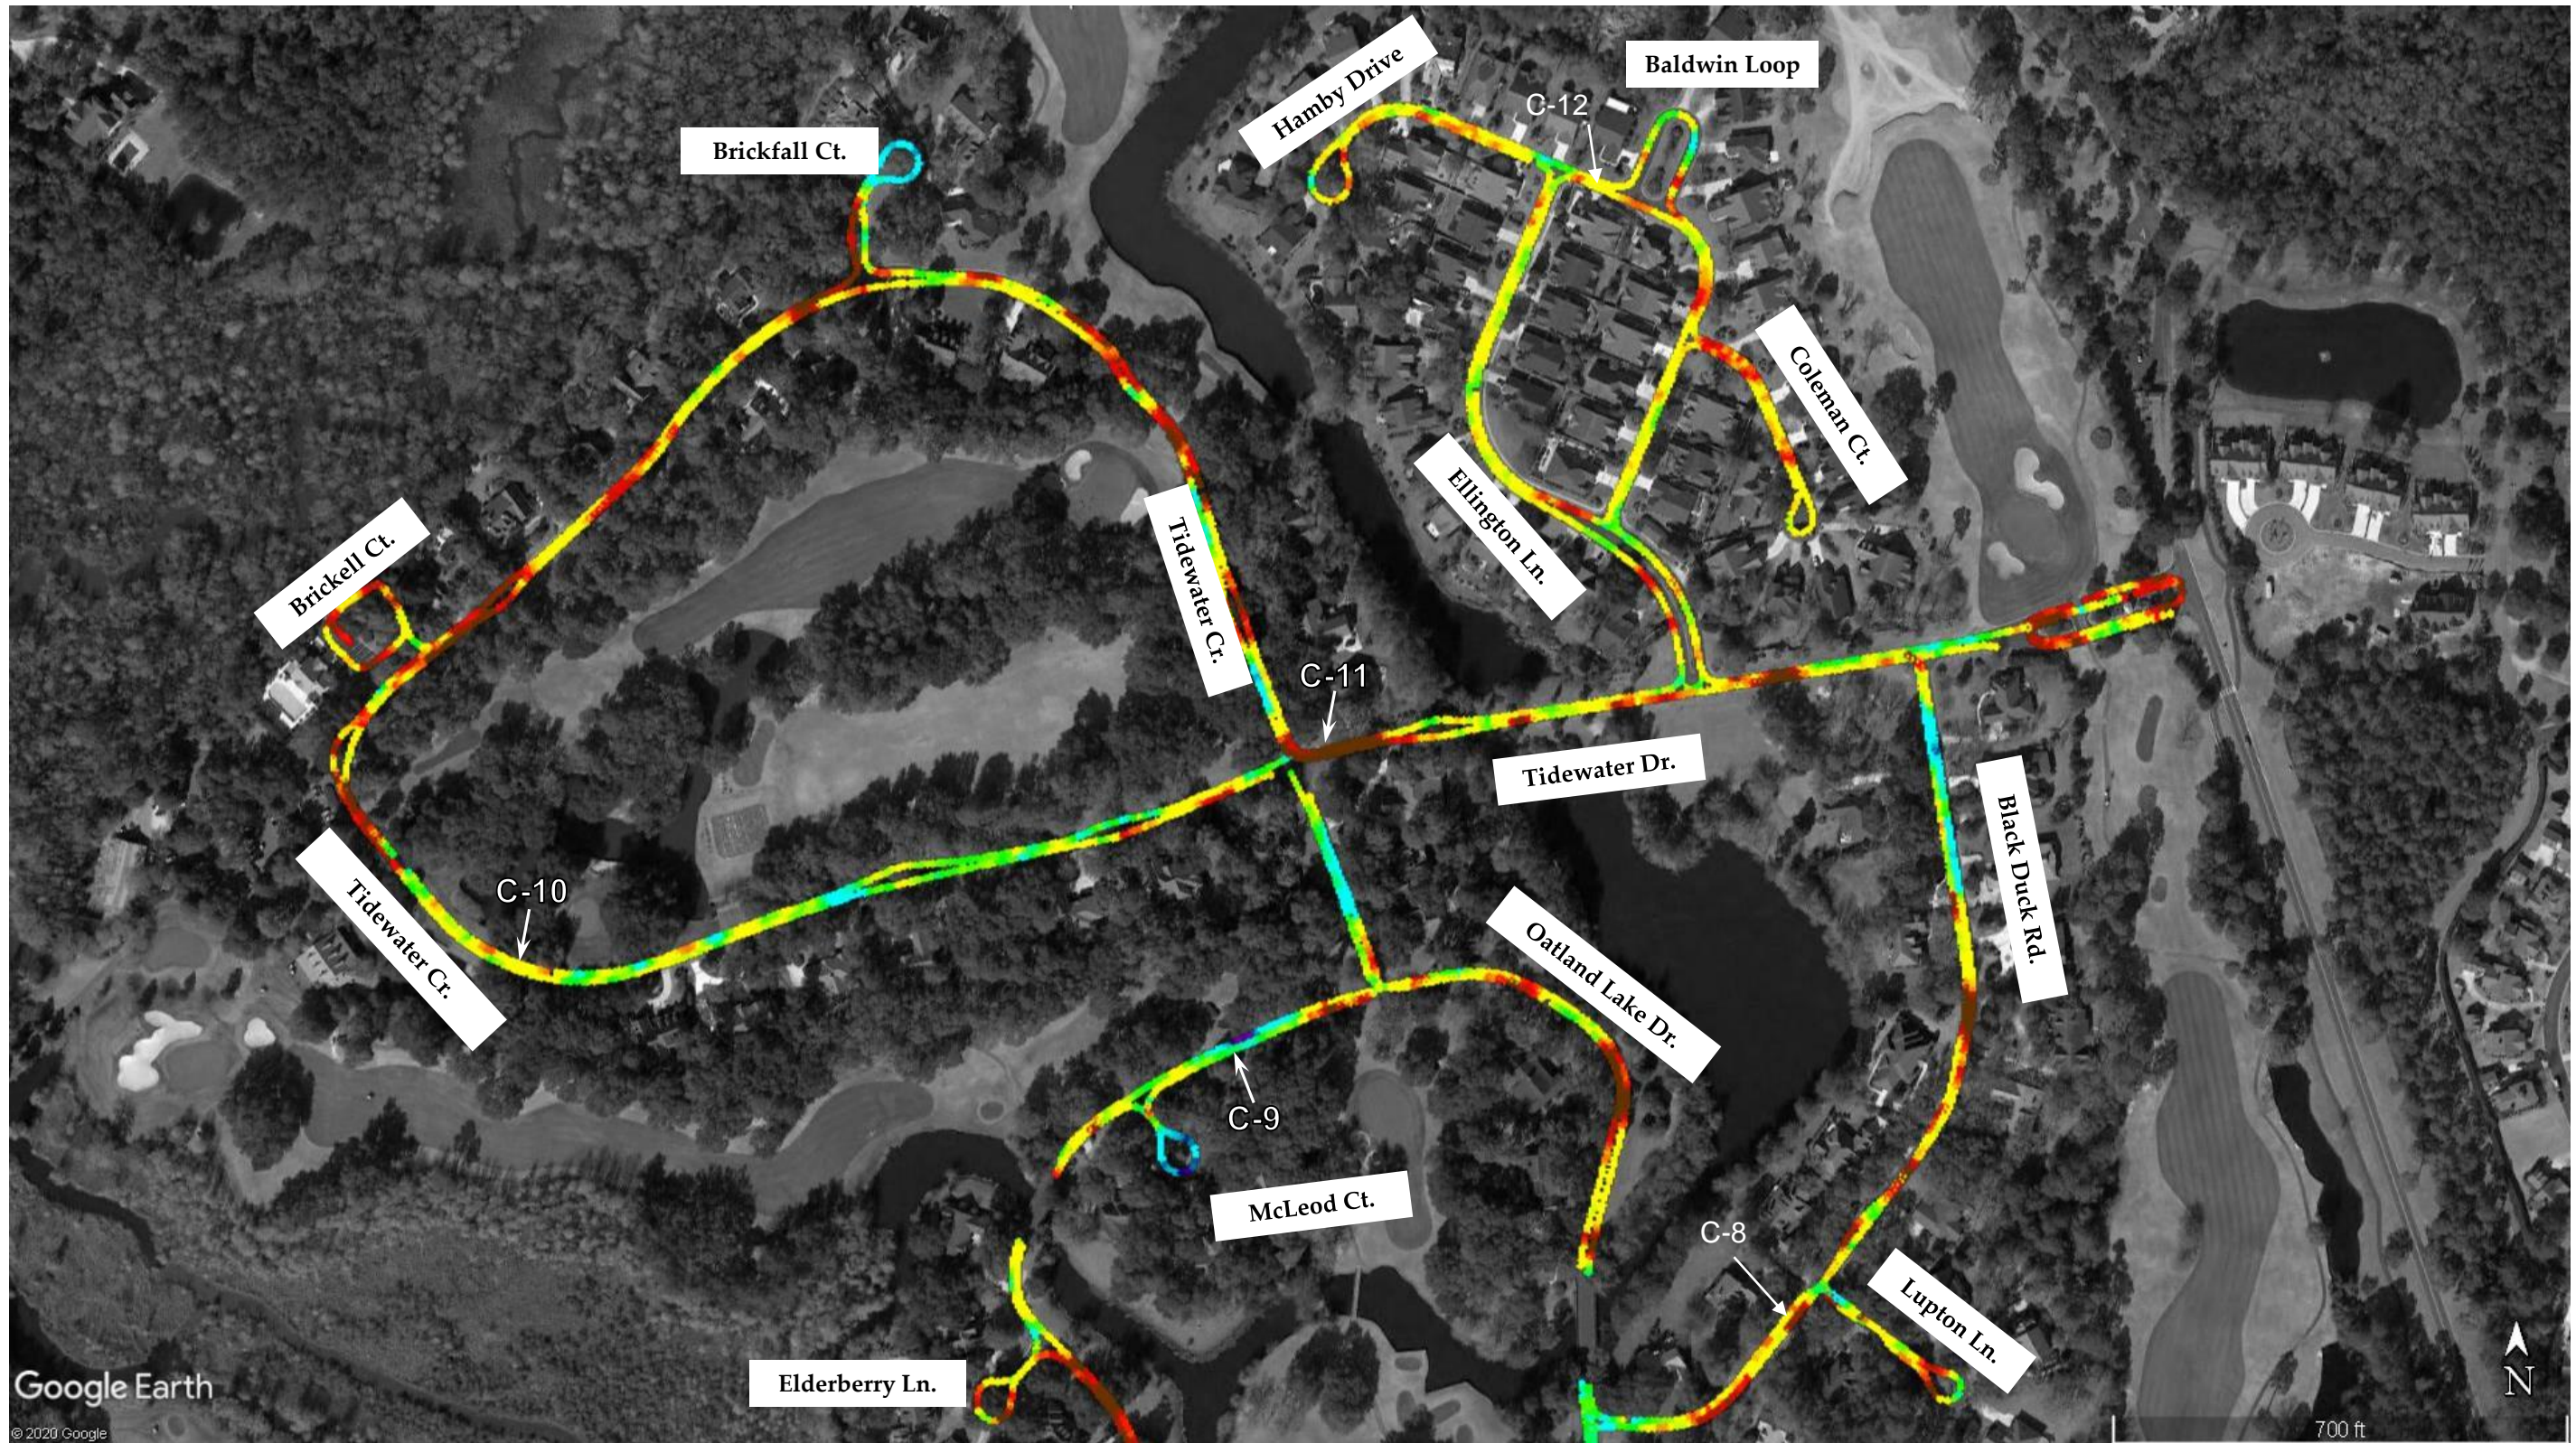
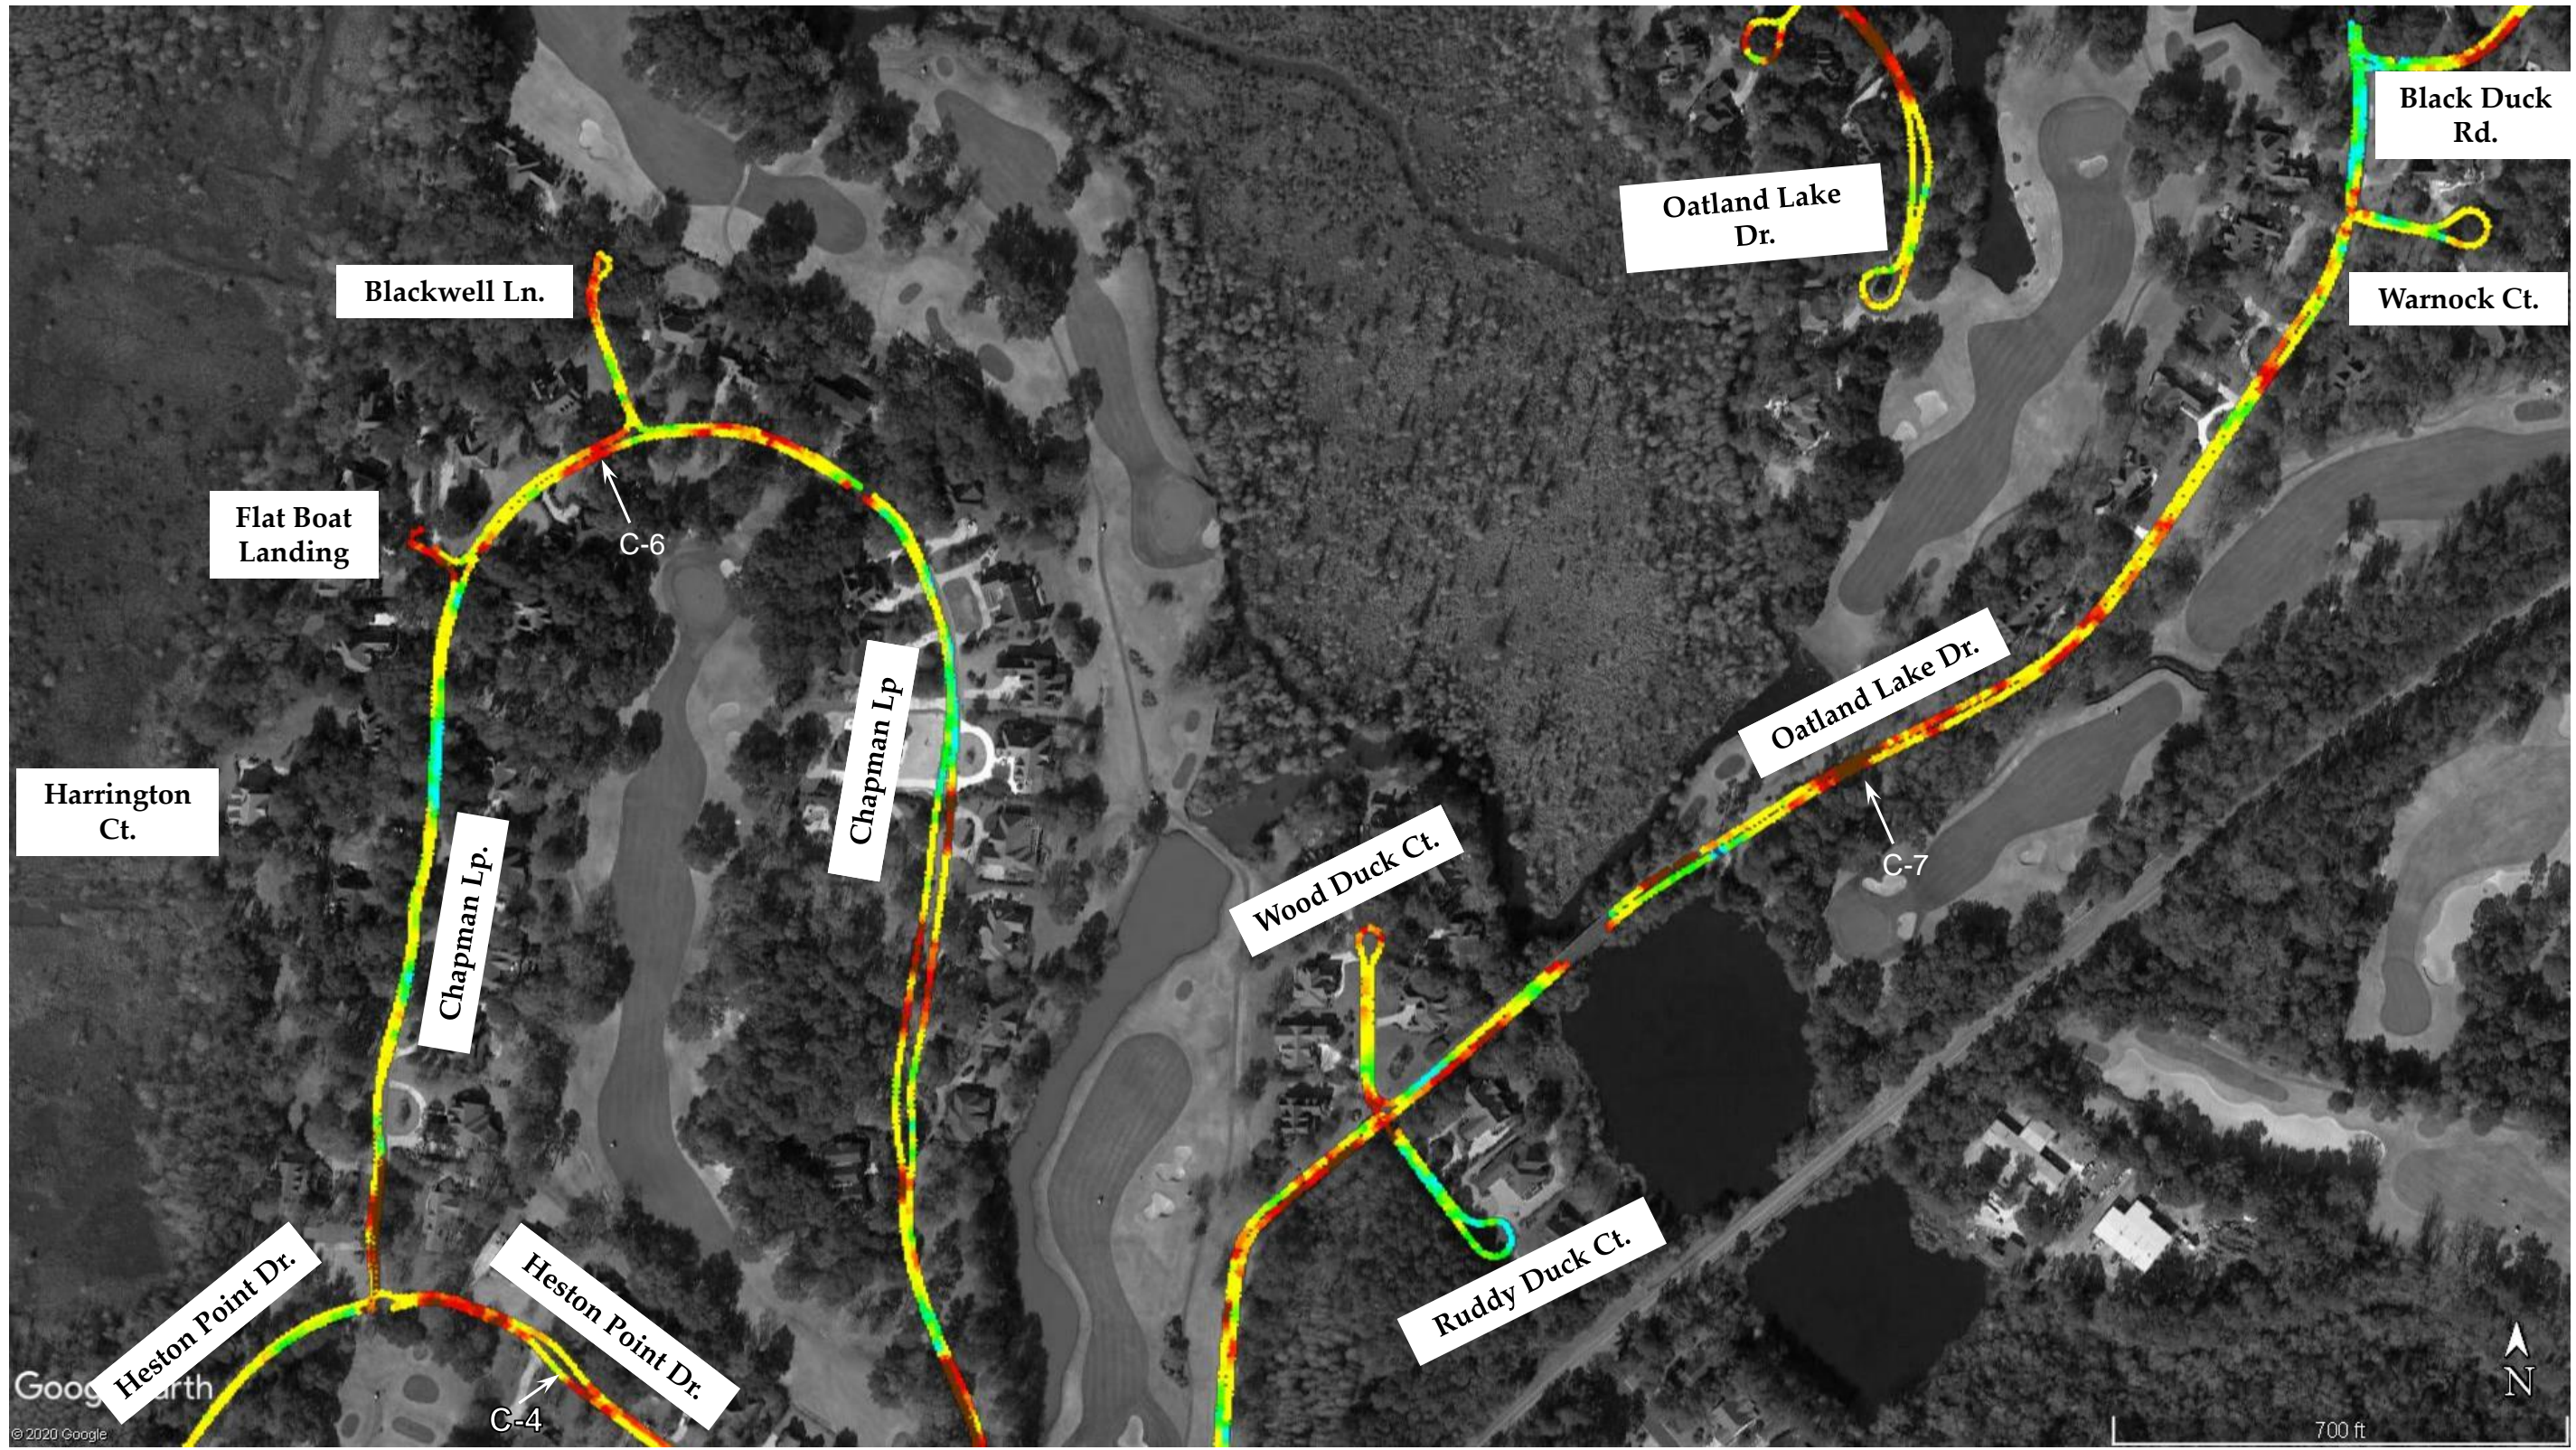
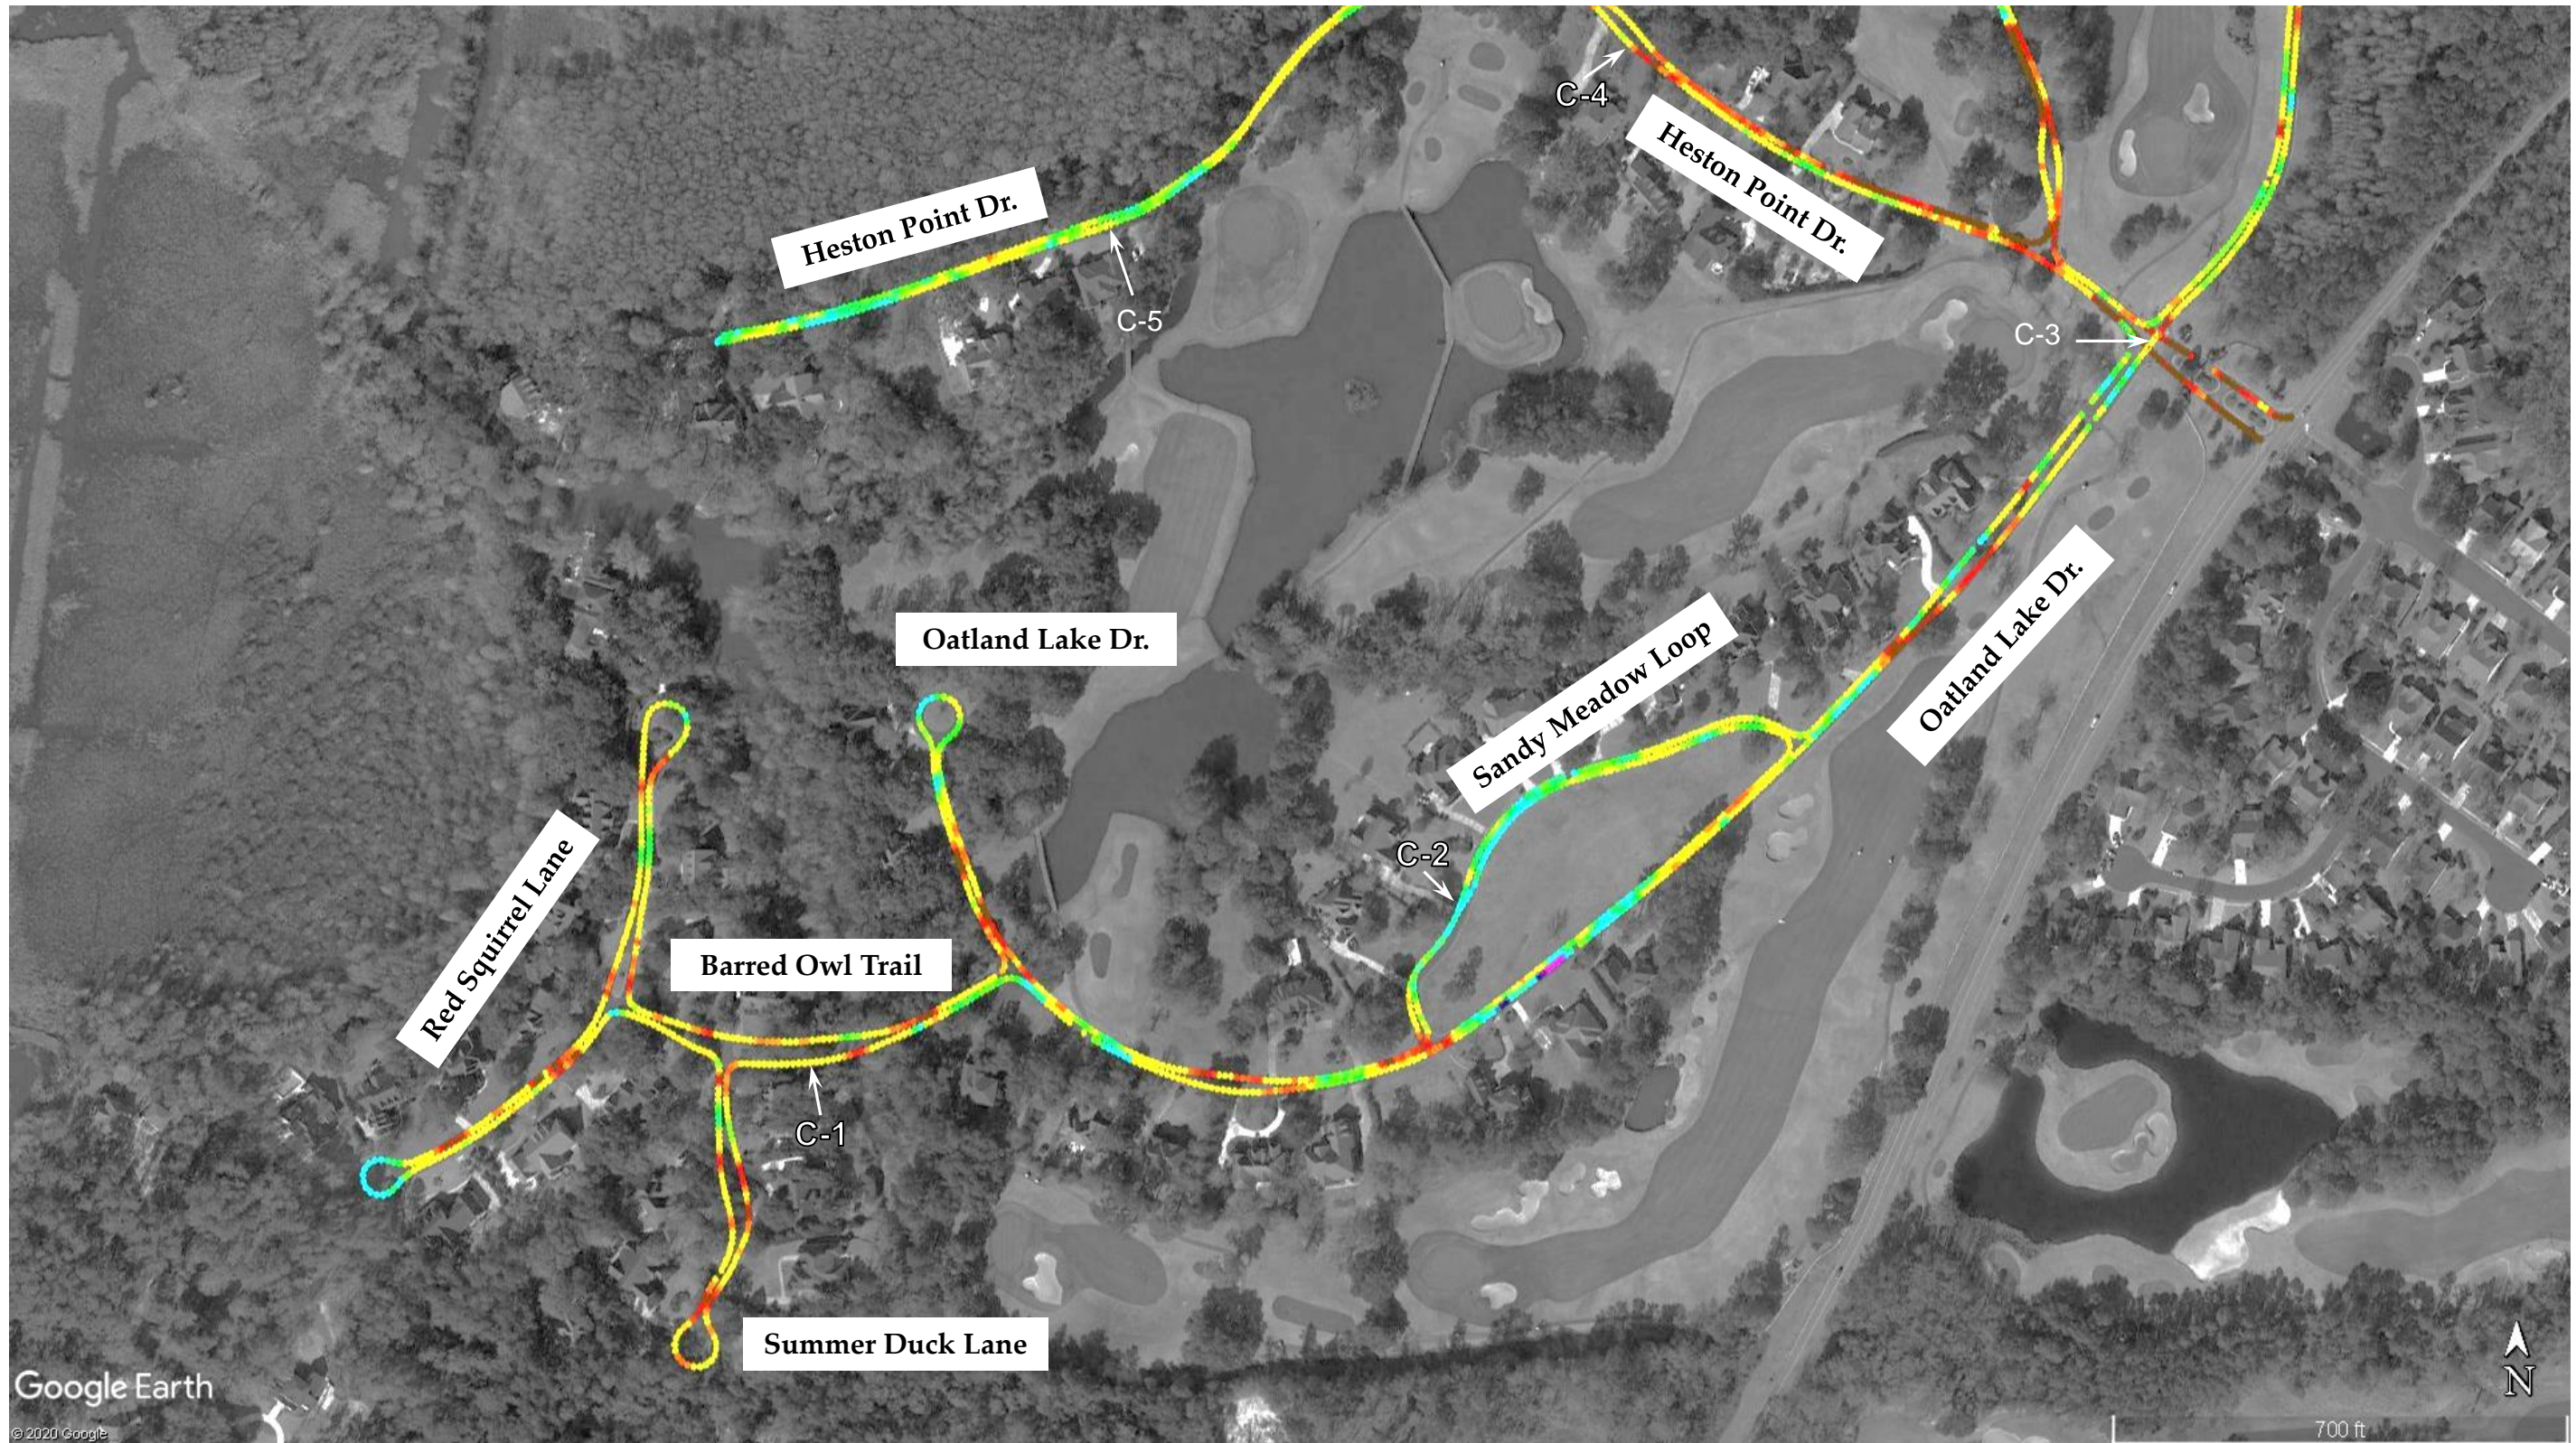
- A. Areas colored in **orange** and **red** on **Figures 2, 4, and 6** indicate areas where the asphalt appears to be less than 2 inches thick.
  - B. Areas colored in **orange** and **red** on **Figures 3, 5, and 7** indicate areas where the base course layer appears to be less than 6 inches thick.

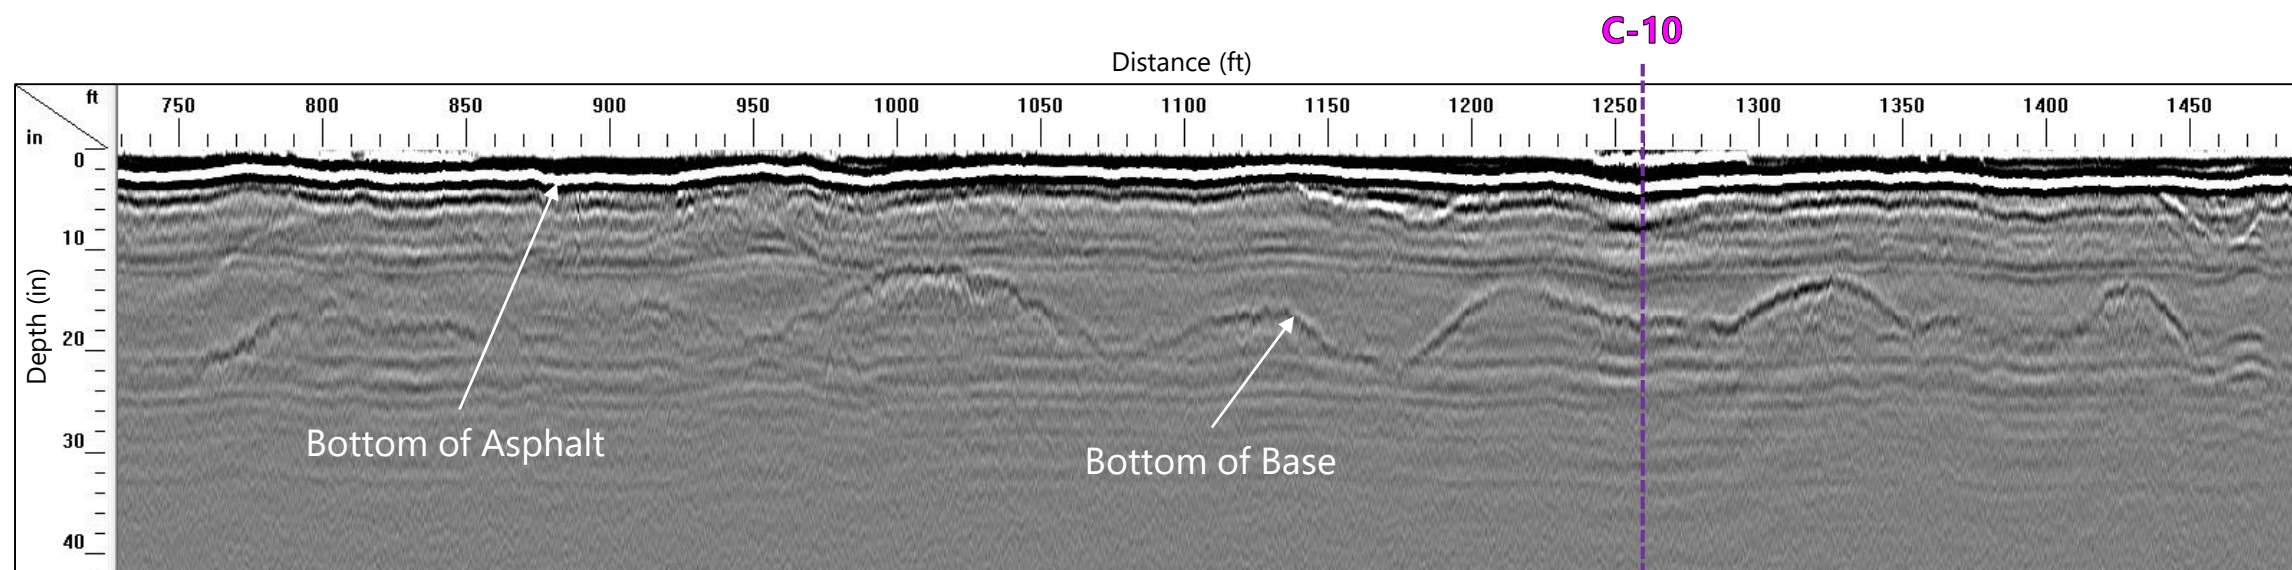
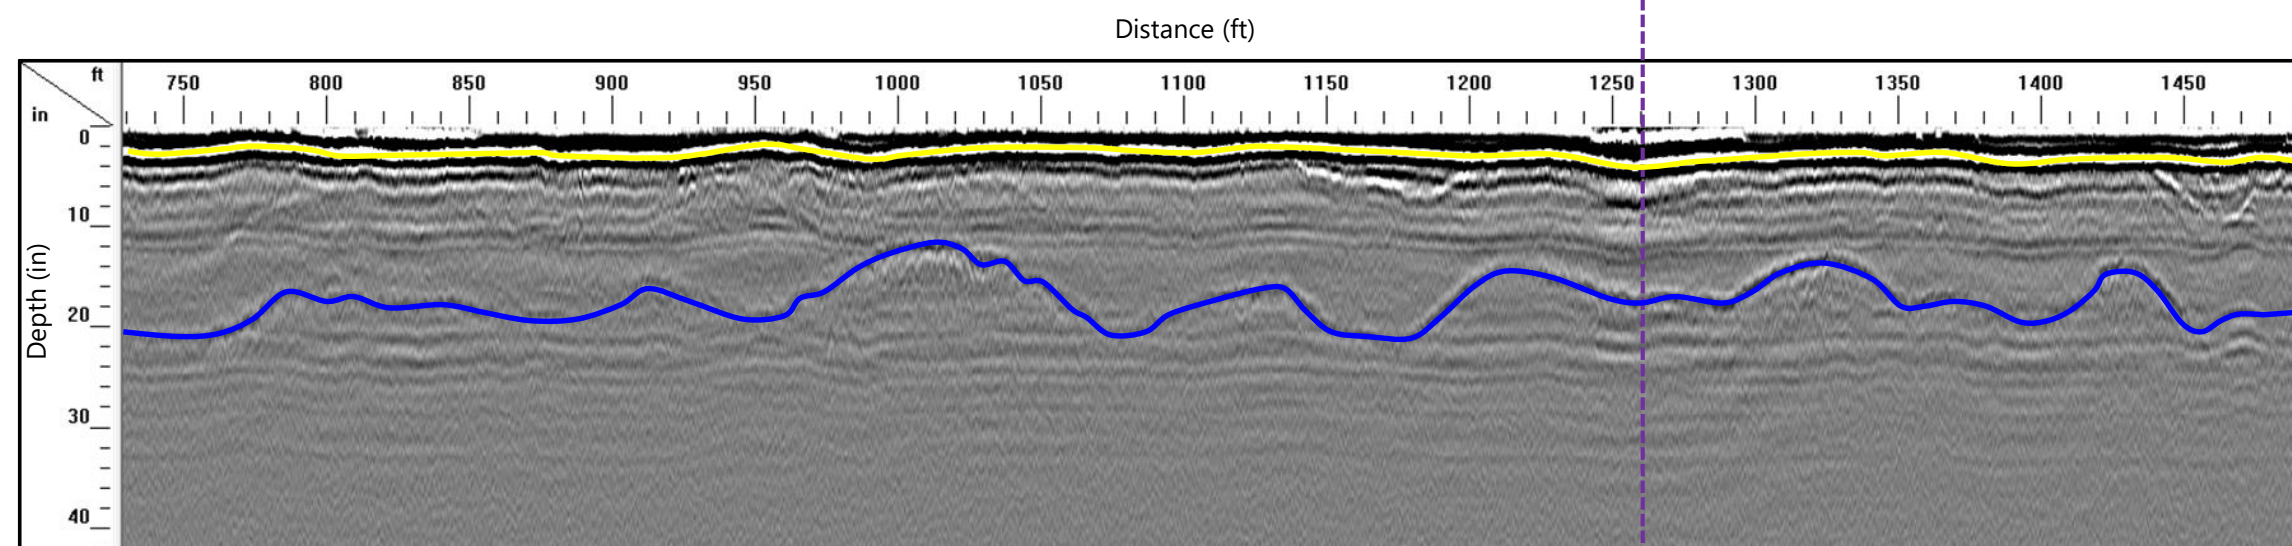
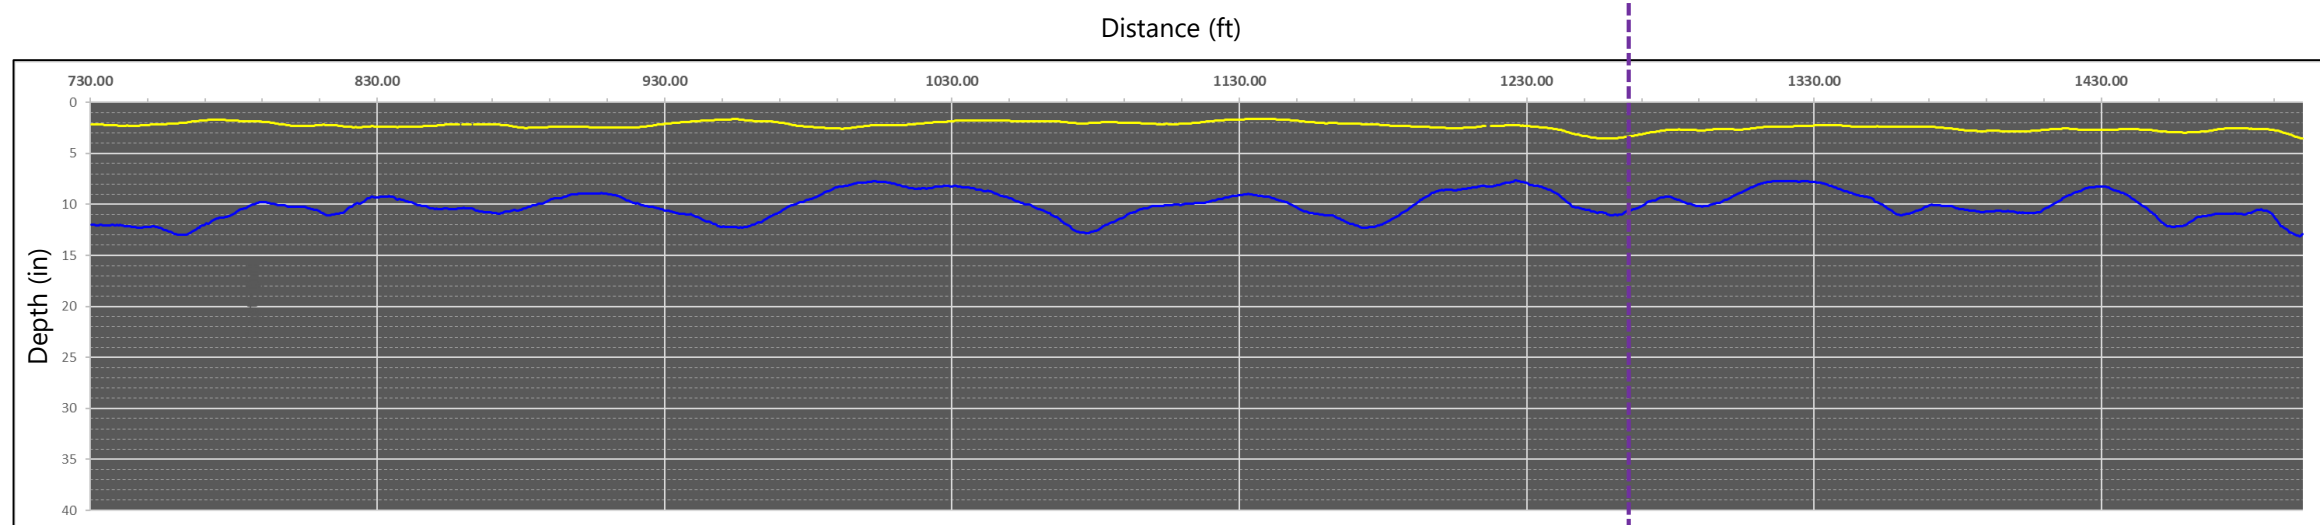
**EXAMPLE GPR PROFILE – CORE C-10**

- A. **Figure 8** illustrates the profile of an approximate 775 ft. long section surrounding core test location C-10 on Tidewater Drive.
  - B. **Figure 9** illustrates the profile of an approximate 775 ft. long section surrounding core test location C-6 on Chapman Loop.
