**DRAINAGE STUDY**

# **WILLBROOK PLANTATION – CHAPMAN LOOP**

**PAWLEYS ISLAND, SC**

Project # 21-00881-002

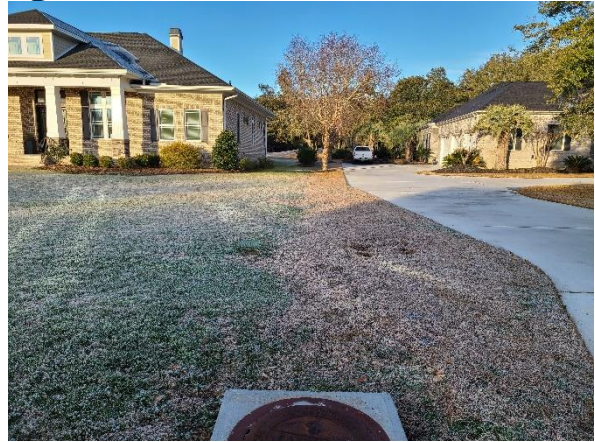
*Photo 2 - Inlet 1 Looking West (Upstream)*

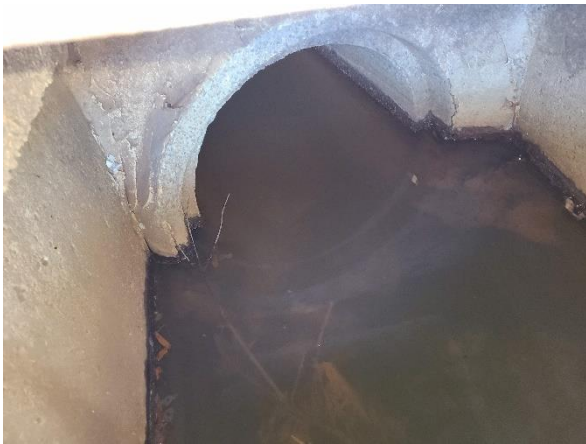
*Photo 3 - Inlet 1 Interior*

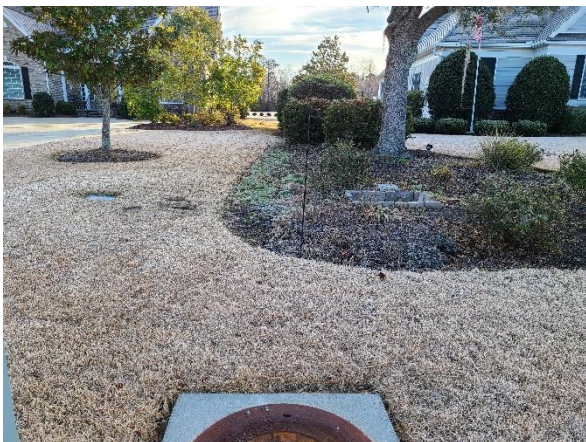
*Photo 5 - Inlet 2 Looking East (Downstream)*

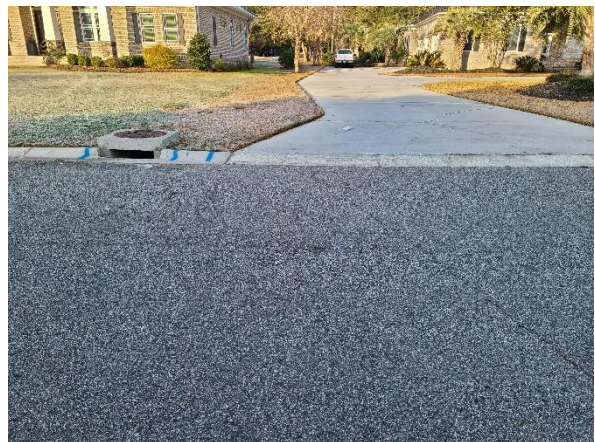
*Photo 6 - Roadway Section (Inlet 1 in Background)*

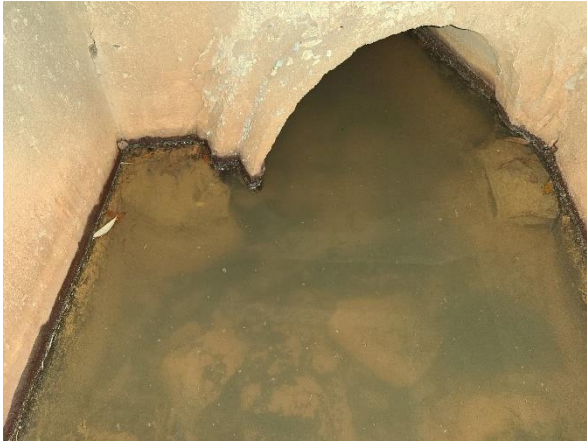
*Photo 7 - Inlet 2 Interior*

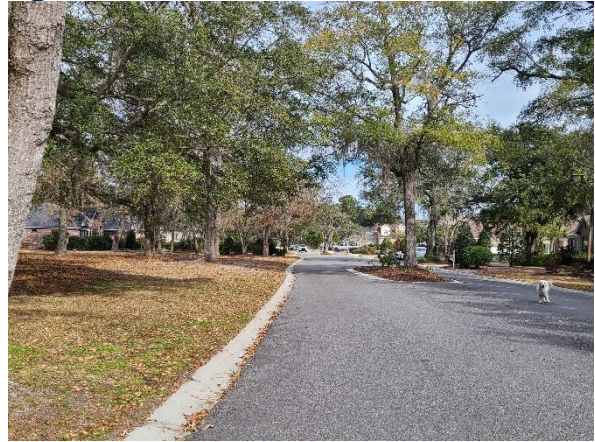
*Photo 8 - Southern High Point Near 123 Chapman Loop*

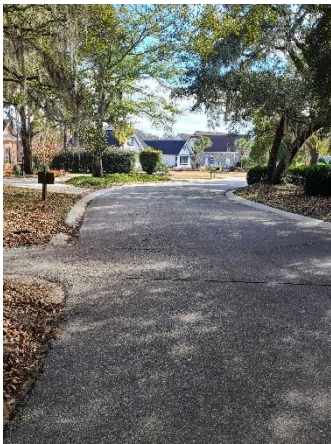
*Photo 9 - Northern High Point Near 320 Chapman Loop*

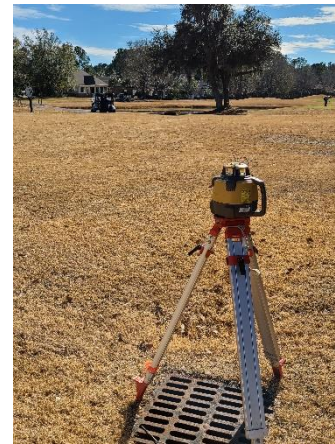
As noted in Storm Drainage System Assessment, the 24" pipe between Inlets 3 and 4 was found to have a negative pipe slope (the pipe invert out is higher than its invert in). Conditions like this inhibit the free draining capacity of the system and will cause stormwater runoff to remain in the system after the runoff event has concluded. In this case, the negative slope is causing a 1.5' elevation difference between the structures which is more significant than what we would normally see when negative pipe slopes are encountered. During larger storm events, this can cause stormwater runoff to back up in the system and lead to inlet surcharging (water coming out of the inlet opening) in the upstream Inlets 1&2. Preliminary hydraulic 1-D modeling indicates that this negative pipe slope is leading to surcharging upstream of this pipe, however, extents of the flooding were unable to be confirmed due to the limitations of a traditional 1-D model and topographic information.

*Photo 10 - Inlet 3 Looking Southeast (Downstream)*

Recommendations – Reconstruct the storm drainage system from Inlet 2 to the outfall into the golf course pond to provide positive pipe slopes. This will restore the free-flowing capacity of the system to its designed intent.

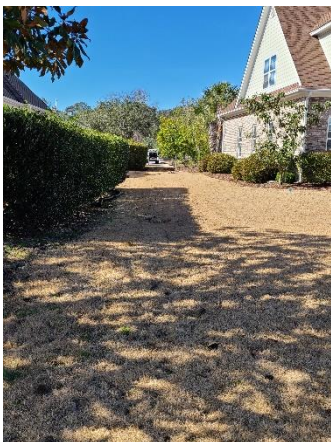
*Photo 11 - Inlet 3 Looking West (Upstream)*

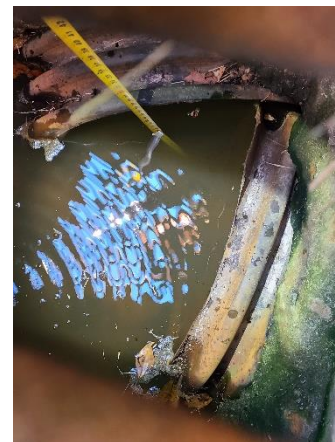
*Photo 12 - Inlet 3 Interior*

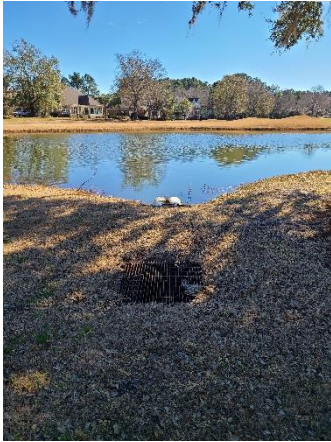
As the storm drainage system continues through Inlet 4, the pipe diameter decreases from a single 24” pipe to dual 12” pipes. Although it might be understood that two 12” pipes are equivalent to one 24” pipe, this is not necessarily the case. This decrease in pipe sizes causes additional hydraulic losses due to friction in the system at Inlet 4, leading to a decrease in the systems overall efficiency.

*Photo 13 - Inlet 5 from Inlet 4 Looking Southeast*

Recommendations – The dual 12” pipes from Inlet 4 to the Outfall should be replaced with 24” pipe to match the pipe diameter of the upstream system at a minimum.

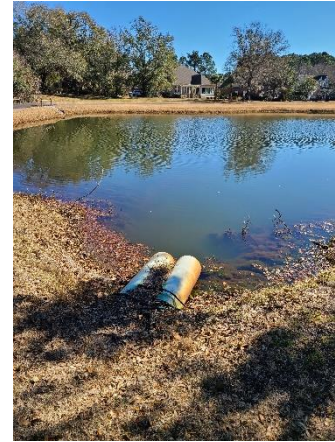
*Photo 14 - System Outlet to Pond*

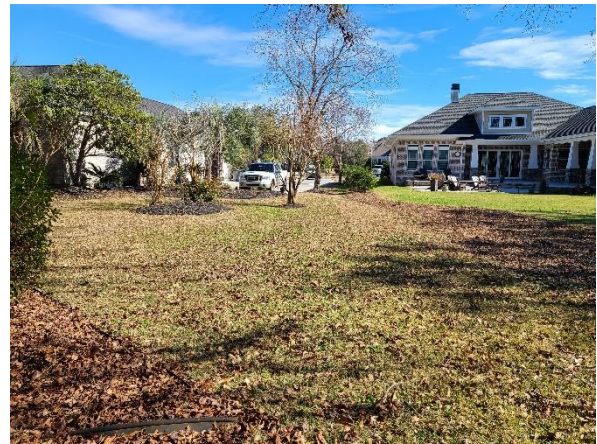
*Photo 16 - Manhole A Looking East (Downstream)*

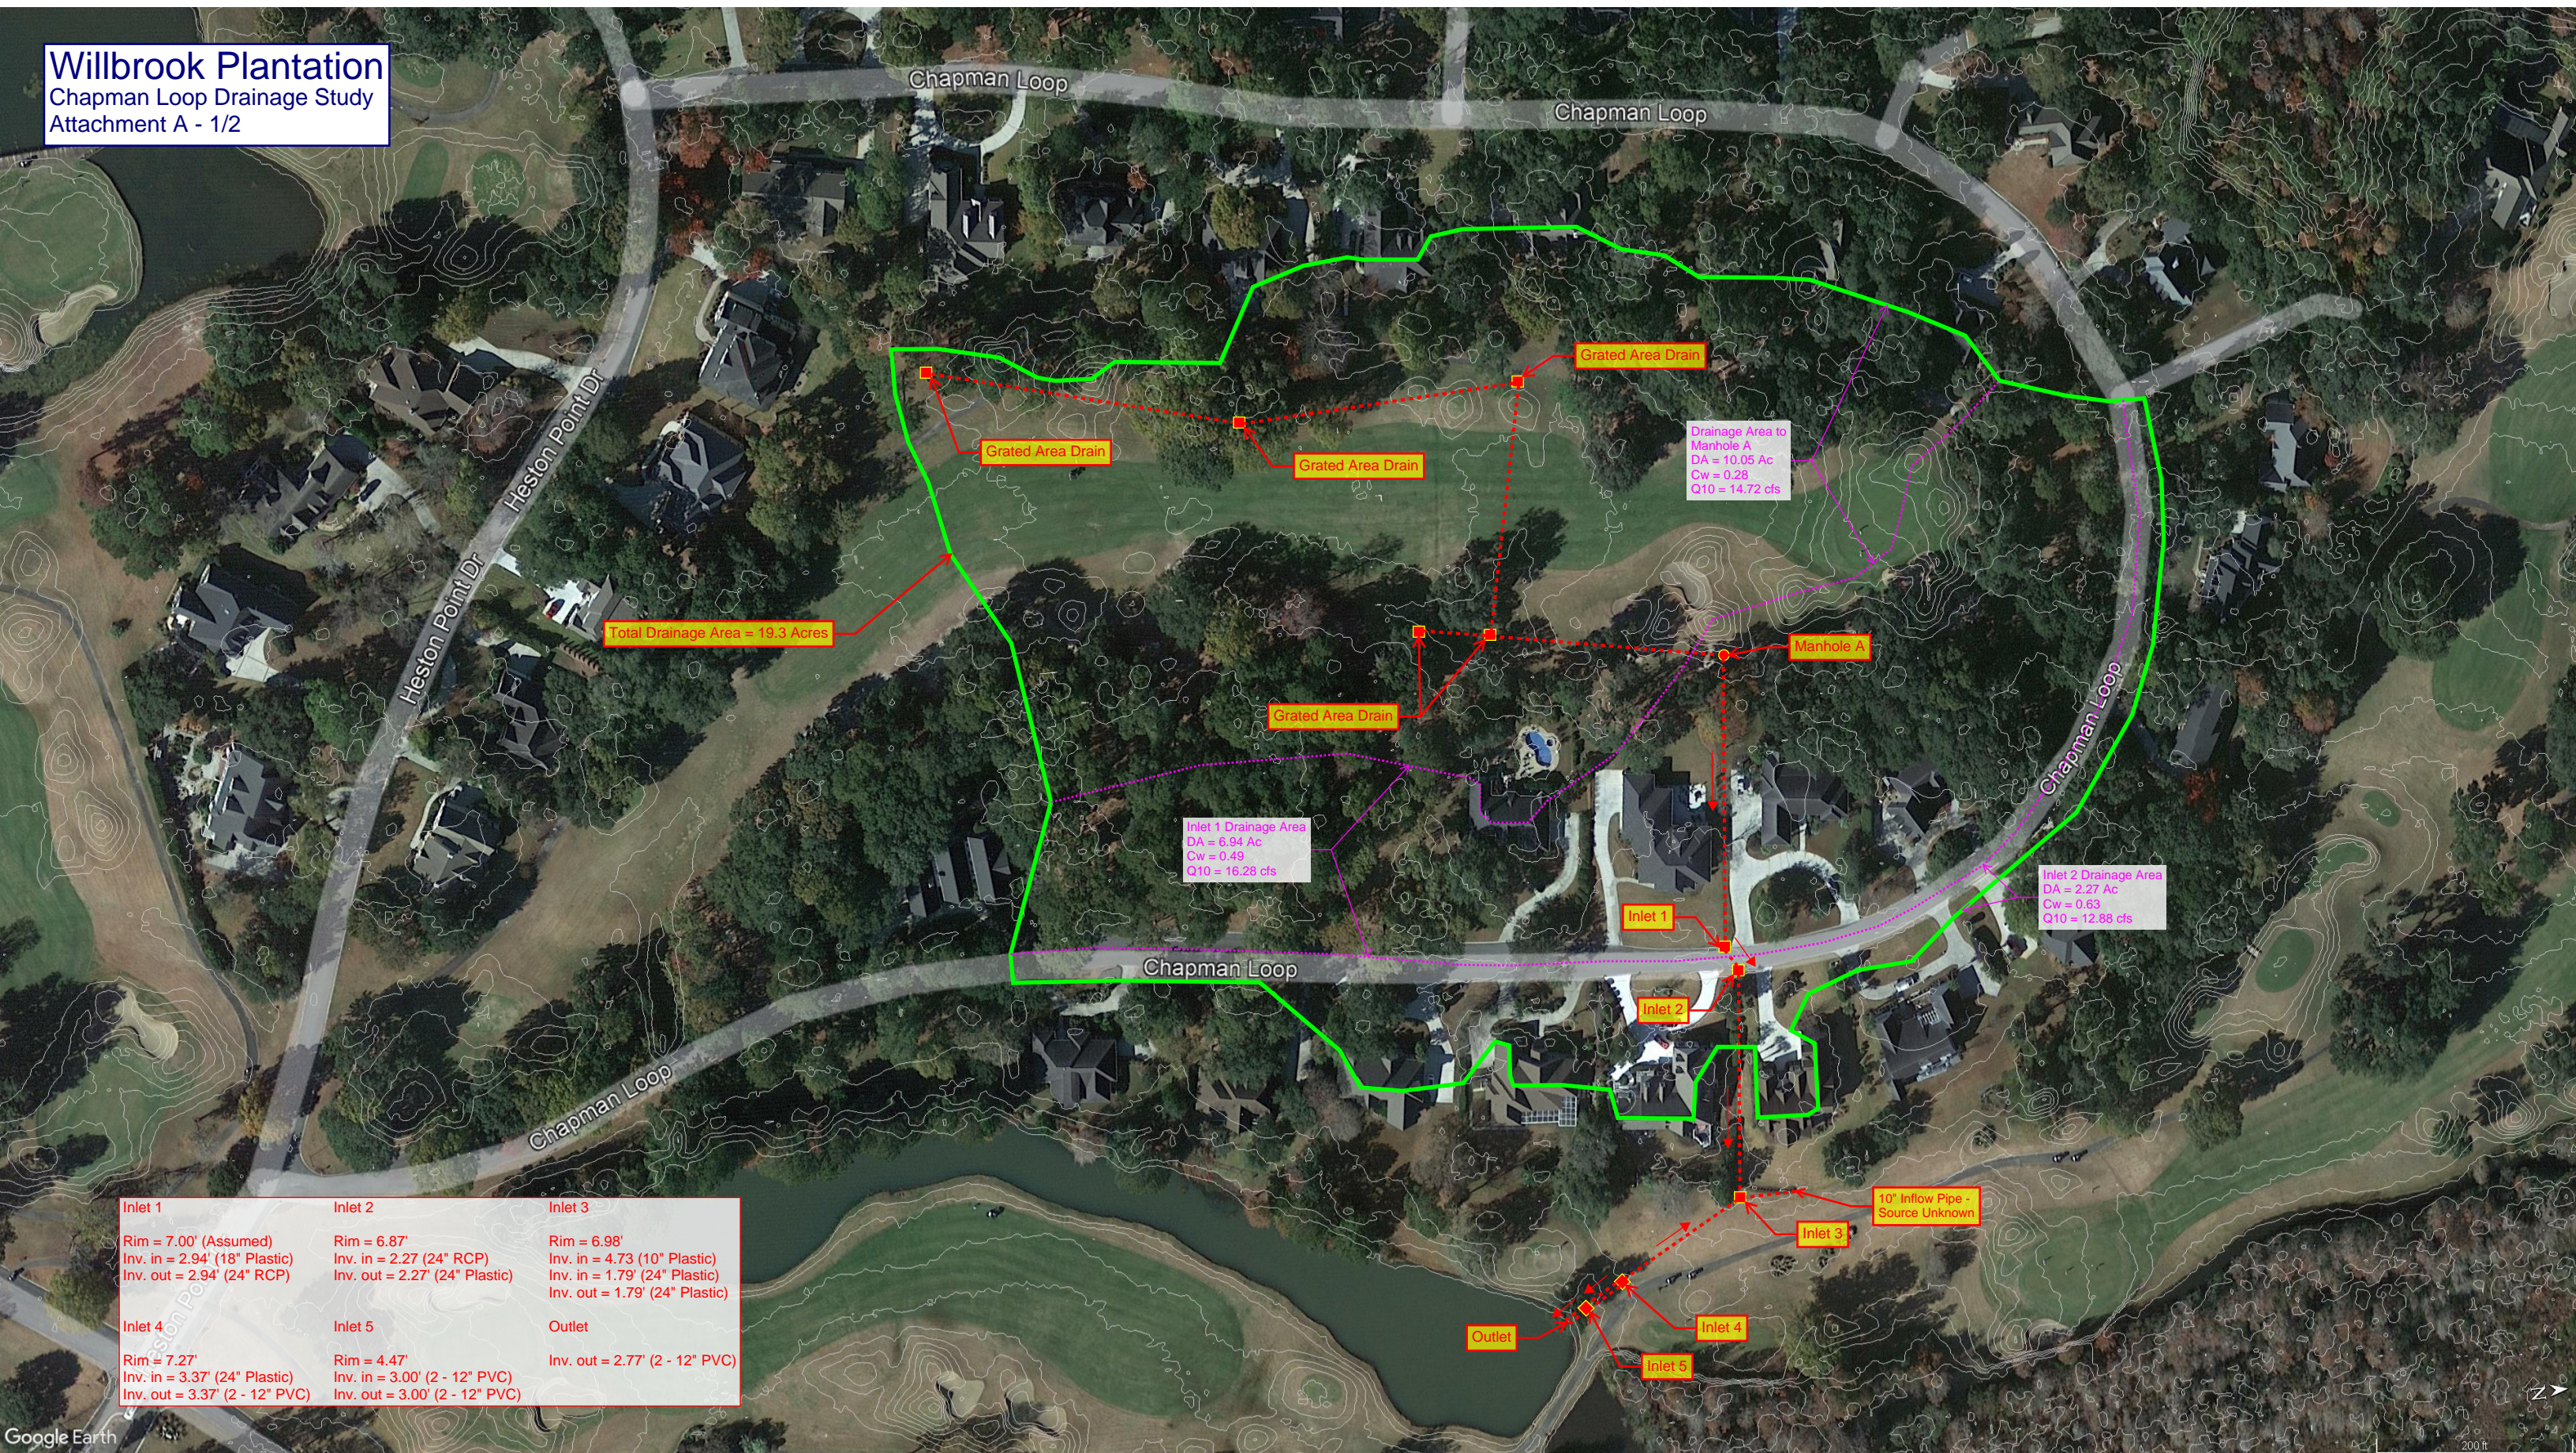
**Willbrook Plantation**  
 Chapman Loop Drainage Study  
 Attachment A - 1/2

Total Drainage Area = 19.3 Acres

Drainage Area to  
 Manhole A  
 DA = 10.05 Ac  
 Cw = 0.28  
 Q10 = 14.72 cfs

Inlet 1 Drainage Area  
 DA = 6.94 Ac  
 Cw = 0.49  
 Q10 = 16.28 cfs

Inlet 2 Drainage Area  
 DA = 2.27 Ac  
 Cw = 0.63  
 Q10 = 12.88 cfs

Inlet 1	Inlet 2	Inlet 3
Rim = 7.00' (Assumed)	Rim = 6.87'	Rim = 6.98'
Inv. in = 2.94' (18" Plastic)	Inv. in = 2.27' (24" RCP)	Inv. in = 4.73' (10" Plastic)
Inv. out = 2.94' (24" RCP)	Inv. out = 2.27' (24" Plastic)	Inv. in = 1.79' (24" Plastic)
		Inv. out = 1.79' (24" Plastic)
Inlet 4	Inlet 5	Outlet
Rim = 7.27'	Rim = 4.47'	Inv. out = 2.77' (2 - 12" PVC)
Inv. in = 3.37' (24" Plastic)	Inv. in = 3.00' (2 - 12" PVC)	
Inv. out = 3.37' (2 - 12" PVC)	Inv. out = 3.00' (2 - 12" PVC)

10" Inflow Pipe -  
 Source Unknown

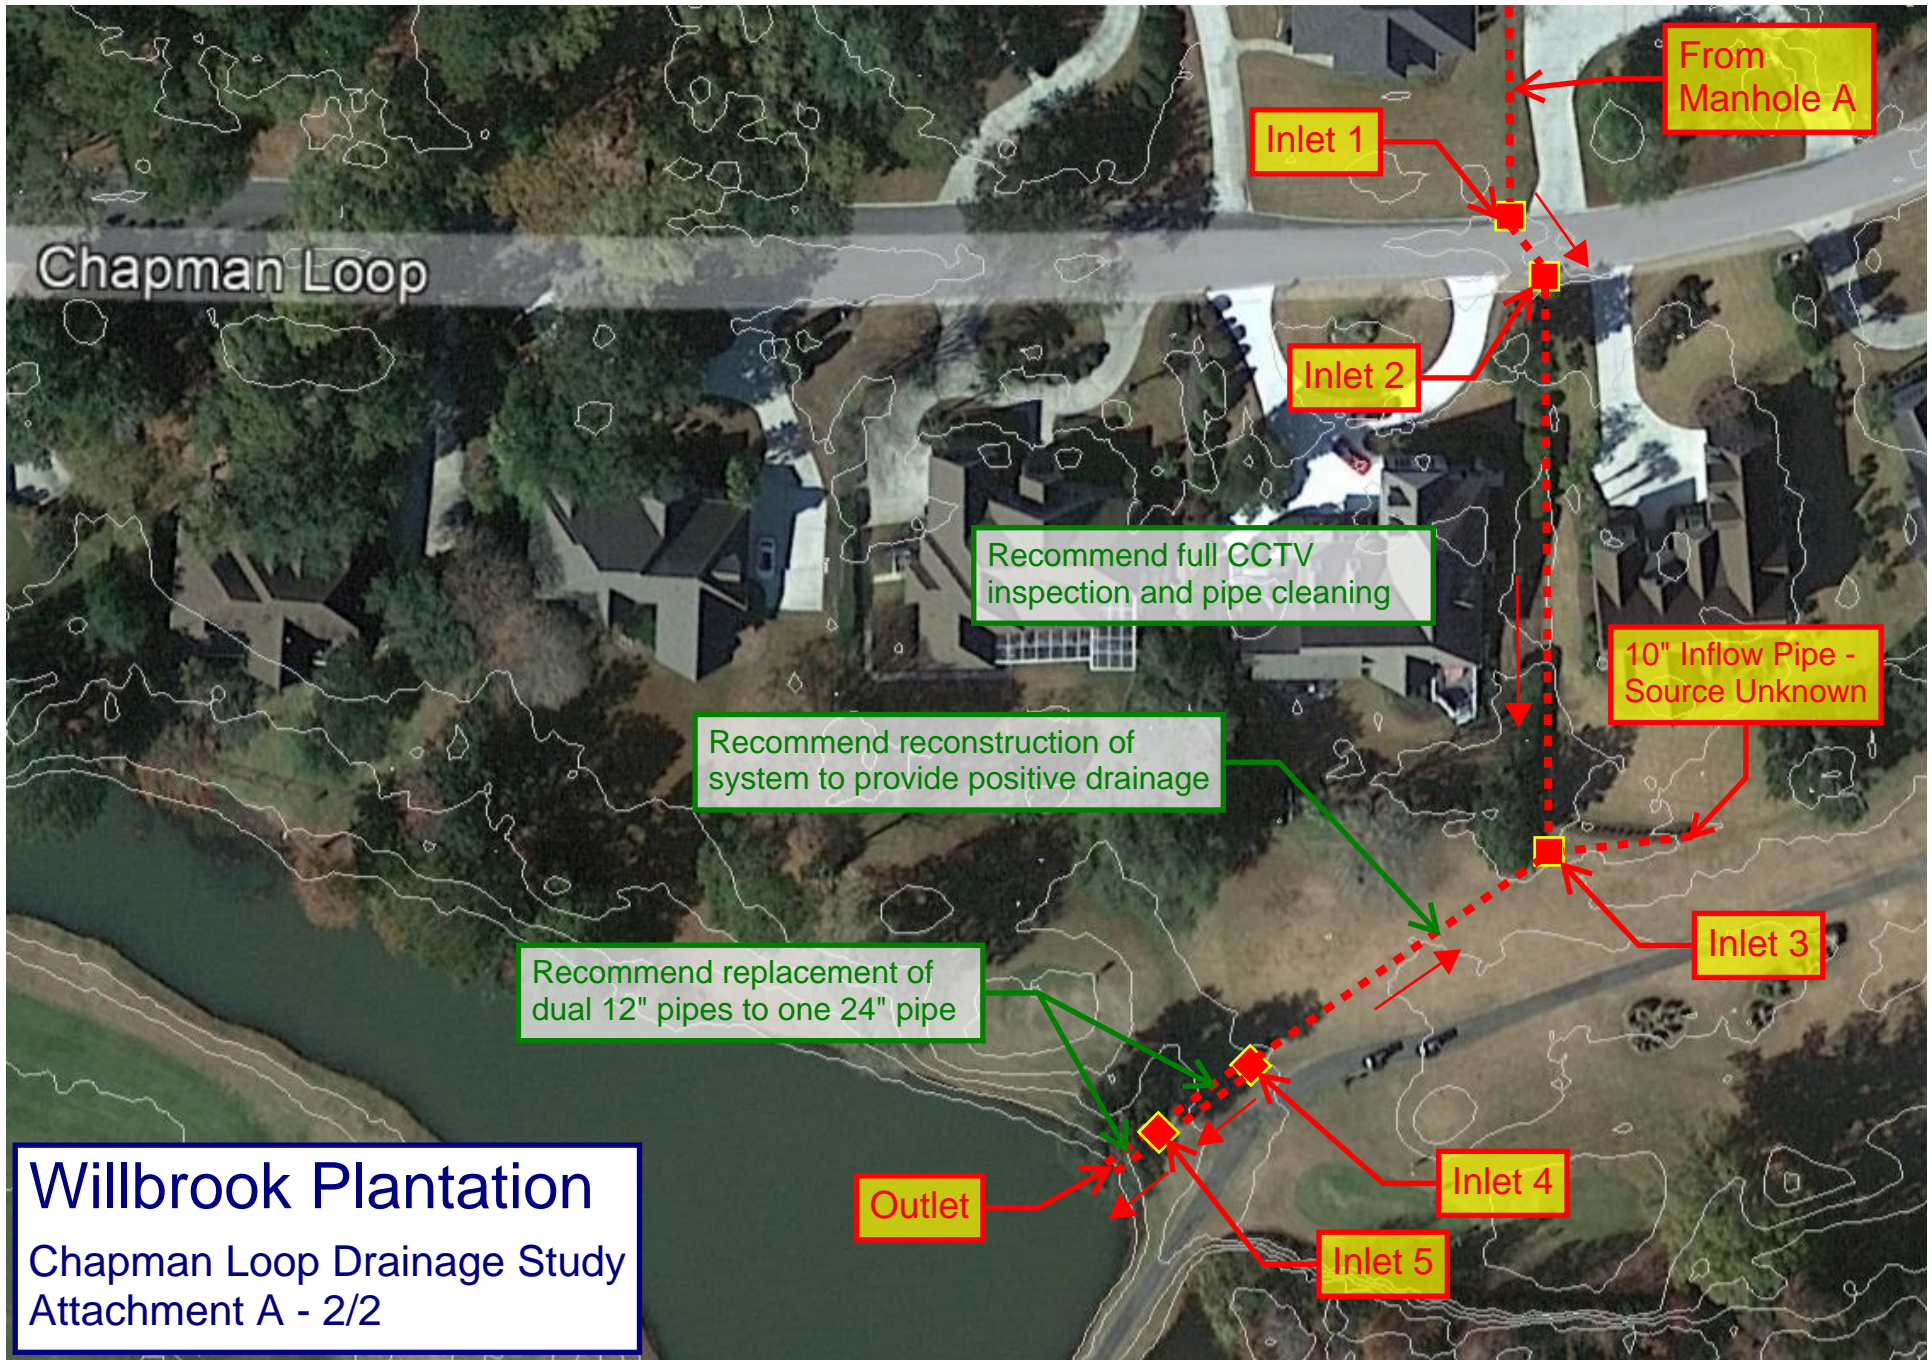
**Willbrook Plantation**  
Chapman Loop Drainage Study  
Attachment A - 2/2

10" Inflow Pipe - Source Unknown

Recommend full CCTV inspection and pipe cleaning

Recommend reconstruction of system to provide positive drainage

Recommend replacement of dual 12" pipes to one 24" pipe
